JUNE 2024

# City of De Pere | De Pere Ice Arena

## Facility Condition Assessment

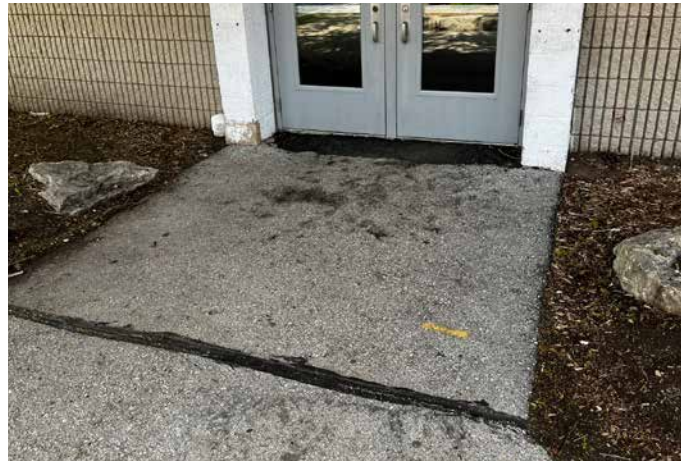
Around the building, there are 5 main egress doors with walks or concrete landings, along with several emergency exits discharging to gravel or grass. The entries have experienced settling of slabs or walkways, creating trip hazards and accessibility compliances issues. The main entry has been patched with asphalt as a temporary solution.

NO CONCRETE STOOP AT MAIN ENTRY

- Remove and Replace pavement at entries to create safe, flush access to doors. Recommend concrete sidewalks.

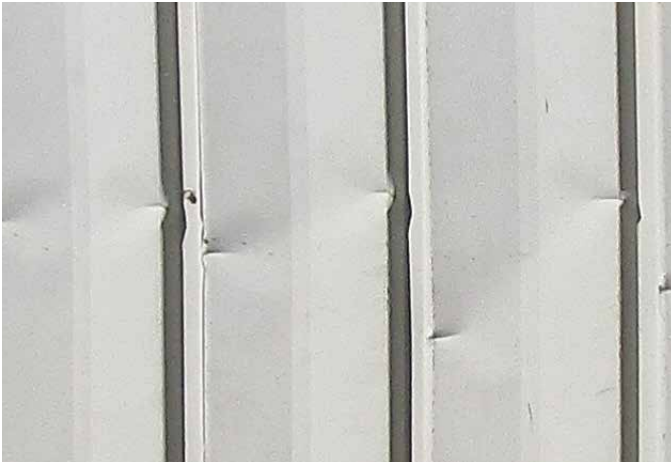
CRIMPED METAL SIDING AT ARENA BASE

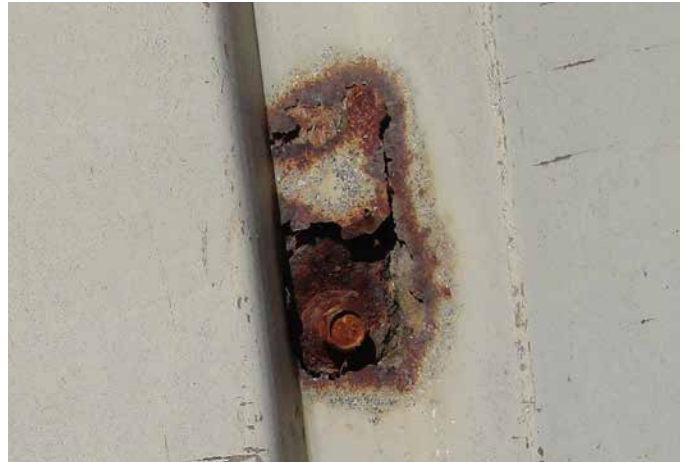
METAL SIDING CONNECTION RUSTED THROUGH

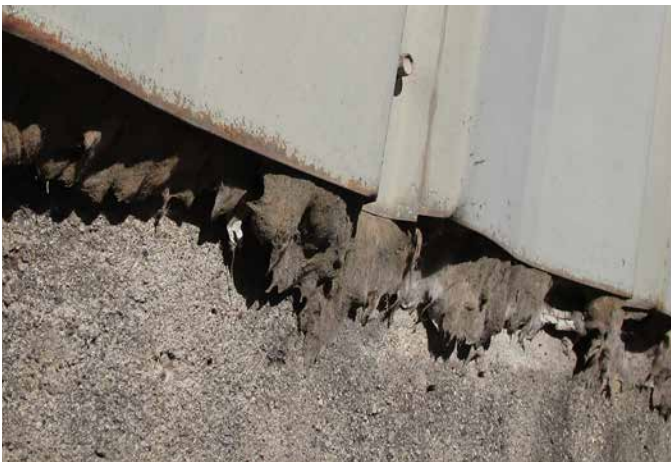
EXPOSED WALL INSULATION AT WALL BASE

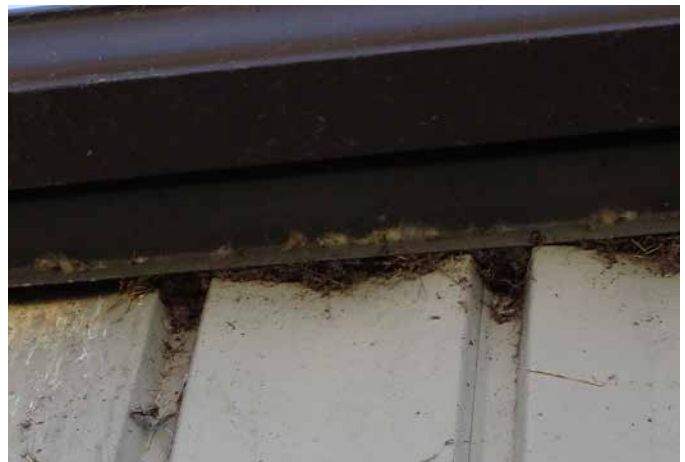
NEST IN SIDING GAPS UNDER THE ROOF GUTTERS

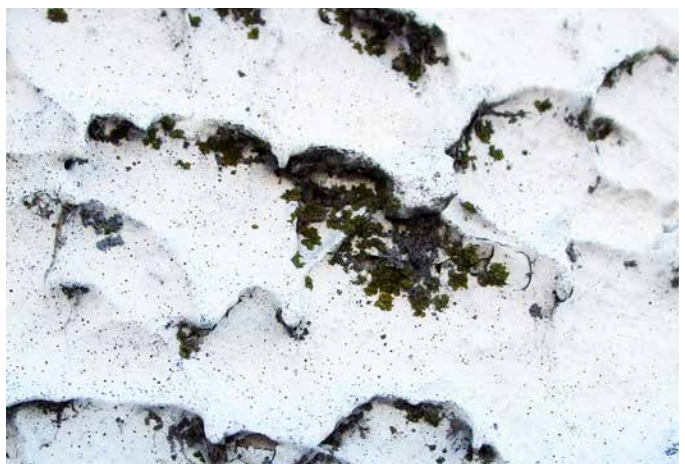
LICHEN GROWING ON BUILDING FACE

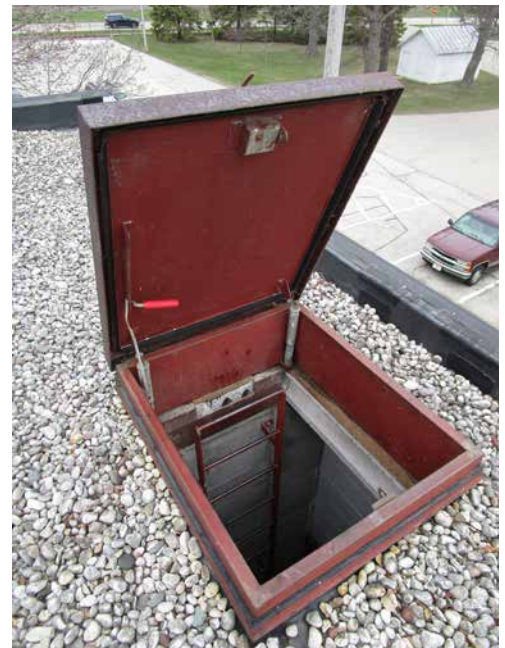
ROOF HATCH INSTALLED BACKWARDS

- Rotate the roof access hatch 180 degrees. The proximity of the hatch opening to the roof edge requires a fall protection safety guard rail. Not only is this a building code requirement, but it's also an OSHA mandate.
- The Arena roofing membrane is in good shape for its age. It should be inspected yearly by a qualified roofer as part of a yearly maintenance routine. Budgetary Planning could start now for a replacement in 2034.

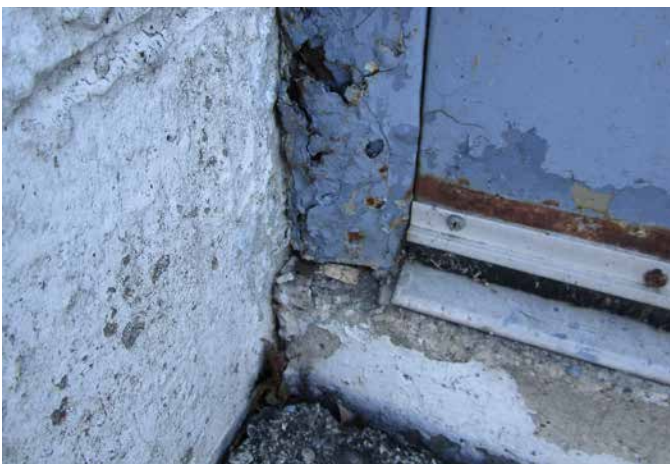
EXTERIOR METAL DOOR FRAME RUSTING

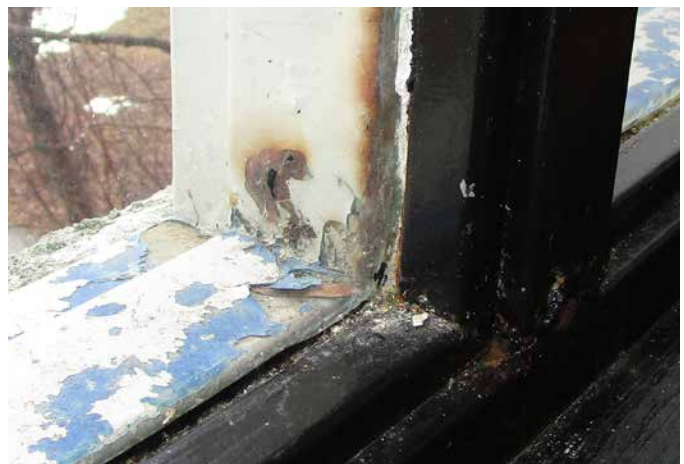
METAL WINDOW FRAME RUSTING FROM THE INSIDE

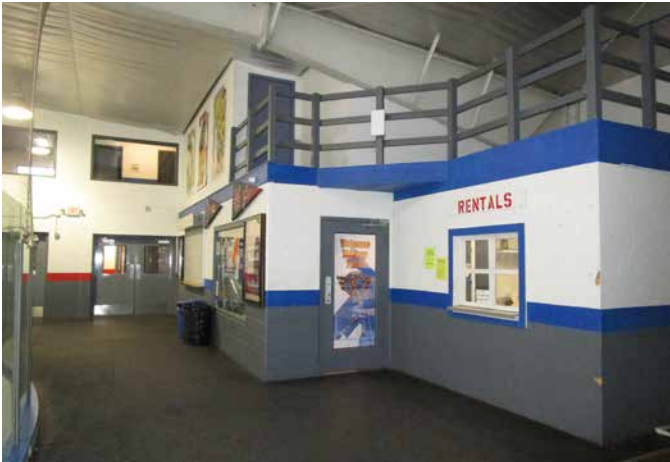
WOODEN STORAGE ROOM ABOVE CONCESSIONS

- Remove storage rooms, or construct a fire rated wall assembly at the 2nd floor storage rooms.

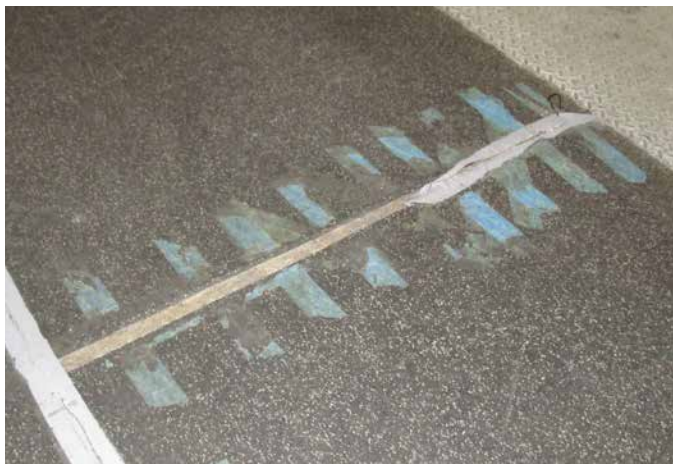
GAPS IN THE RUBBER FLOORING

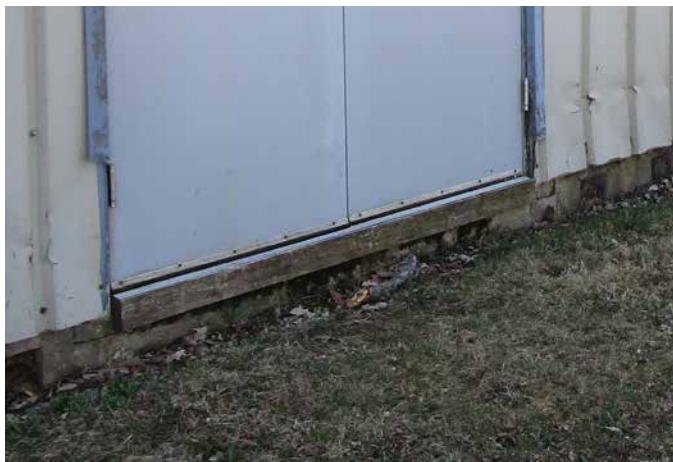
DROP OFF AT EXTERIOR EXIT DOOR

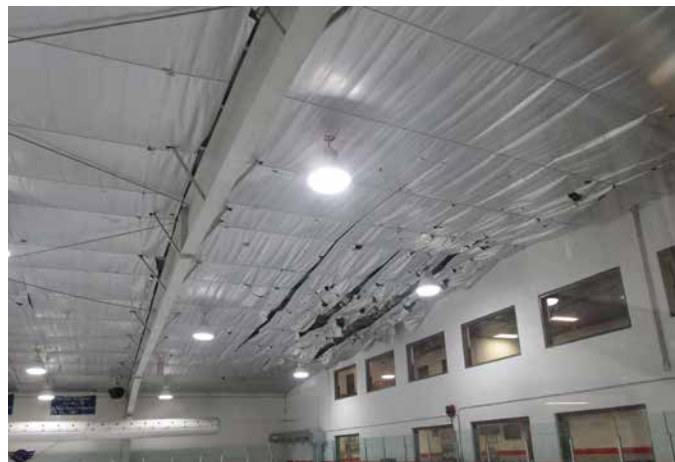
REFLECTIVE MEMBRANE RIPPED BY PUCKS

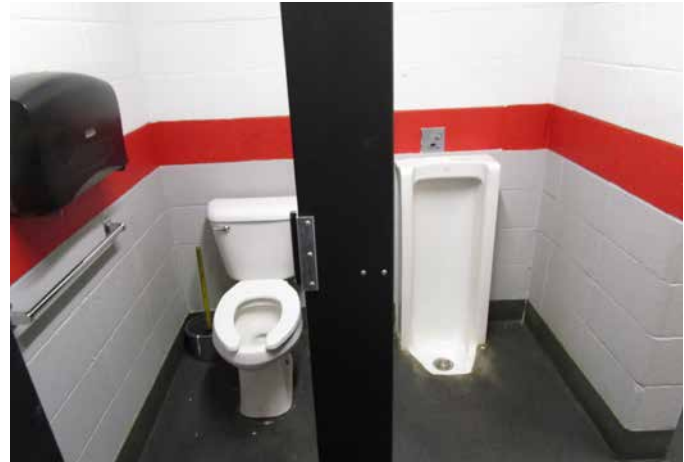
TYPICAL NON-ADA RESTROOM

- At least one ADA accessible toilet room should be constructed in the facility. Often single ADA toilet rooms are called out as Family Restrooms as they are private and big enough for wheelchairs, baby strollers and used by families with small children who can not use the regular restrooms.

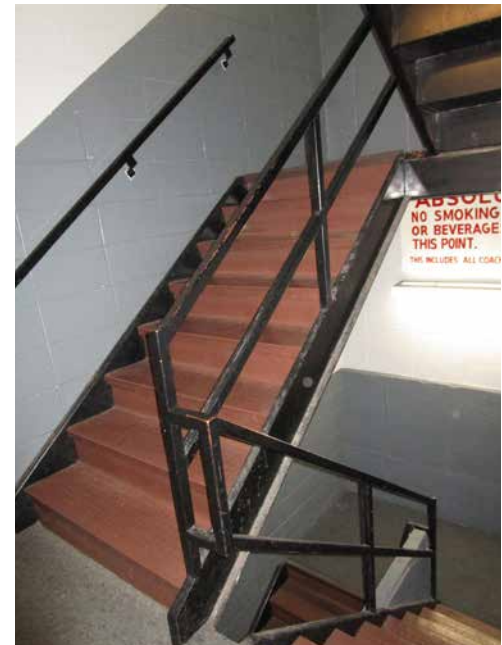
Existing stairways met code in 1974. Codes have changed over the years and the existing railings don't meet the code compliance for rails built today. Only a reconfiguration of more than 50% of the building would require these to be upgraded to current codes.

STAIR GUARD RAILS DO NOT MEET THE CURRENT CODE

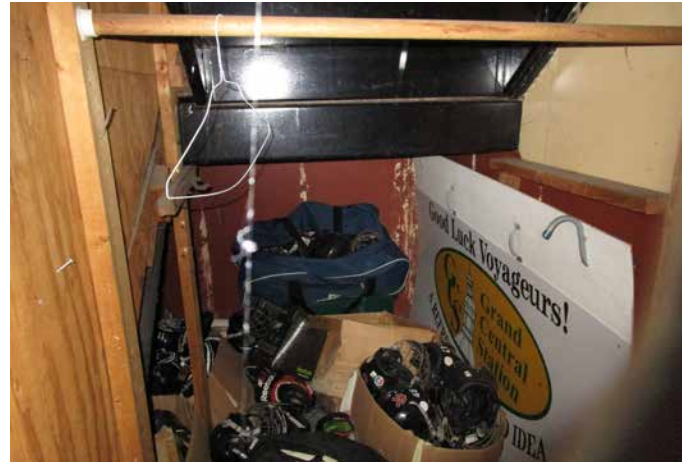
STORAGE UNDER EXIT STAIRWAYS

- All storage items and combustible construction under the stairs should be removed.

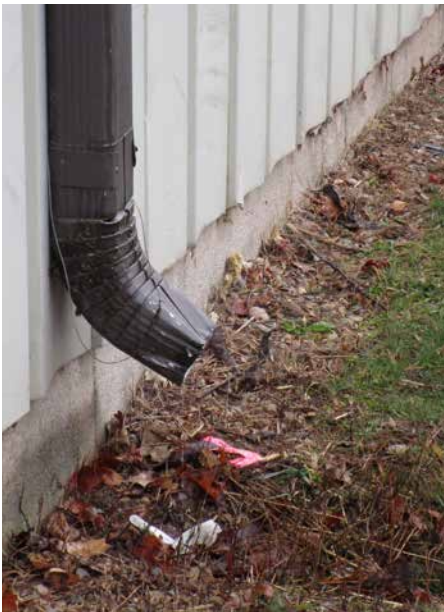
MISSING DOWNSPOUT EXTENSIONS

- Repair downspouts to gutter, add extensions, pipe stormwater away from building.

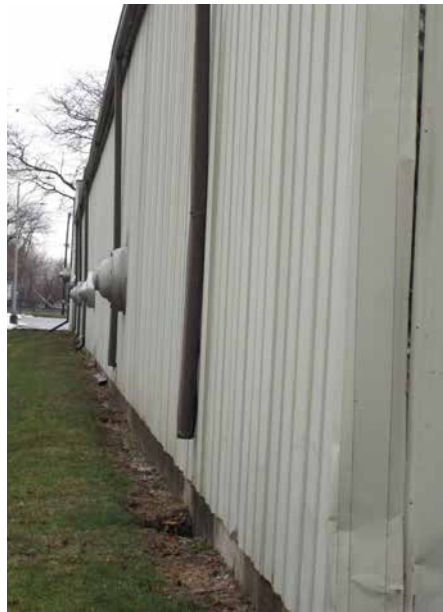
MISSING DOWNSPOUT EXTENSIONS

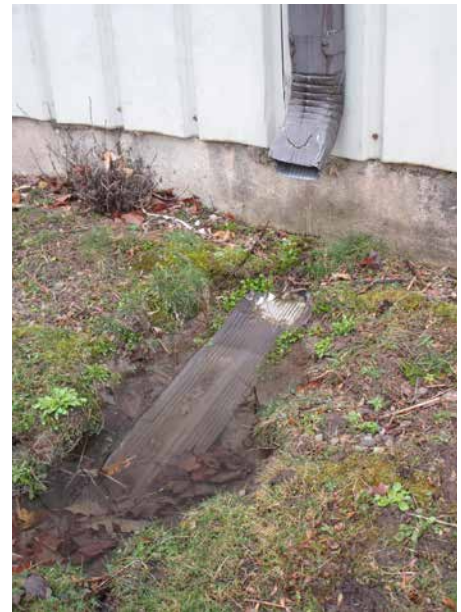
SEVERE PERIMETER GRADE EROSION

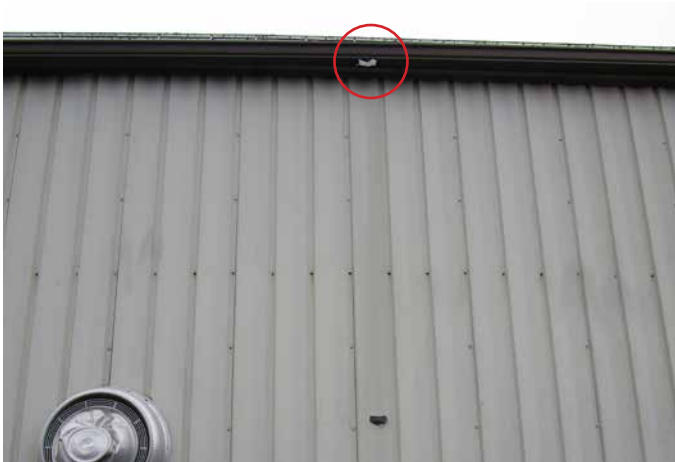
MISSING DOWNSPOUT

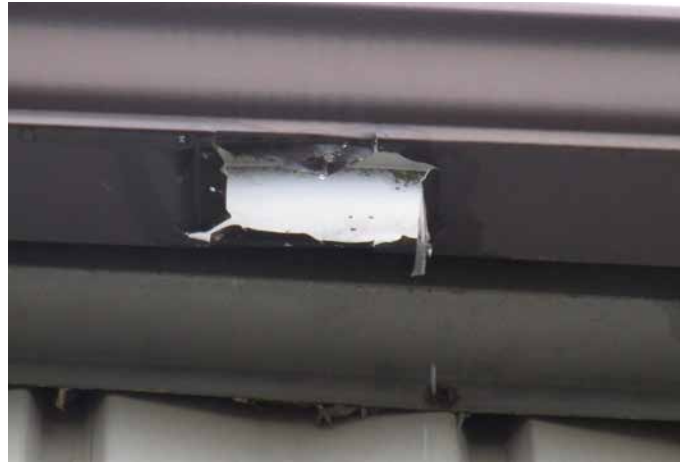
MISSING DOWNSPOUT

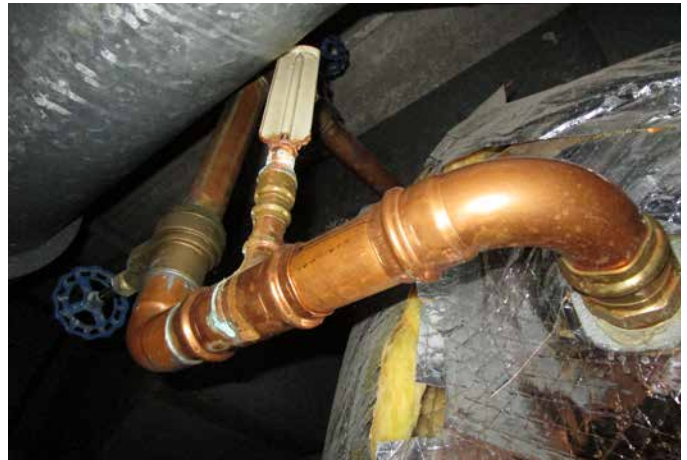
BROKEN THERMOMETER ON HOT WATER STORAGE TANK

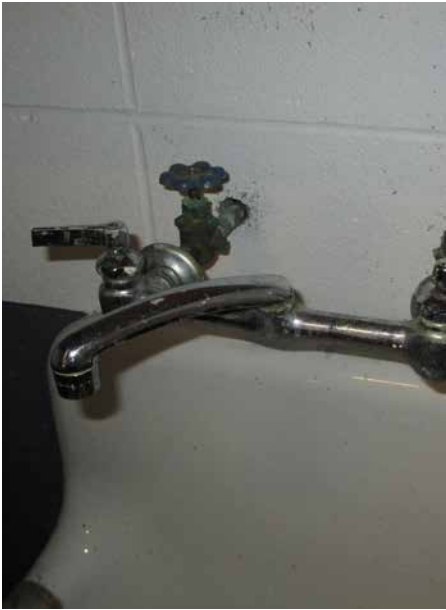
SERVICE SINK MISSING SUPPLY  
SHUT-OFF VALVE HANDLES AND  
VACUUM BREAKER

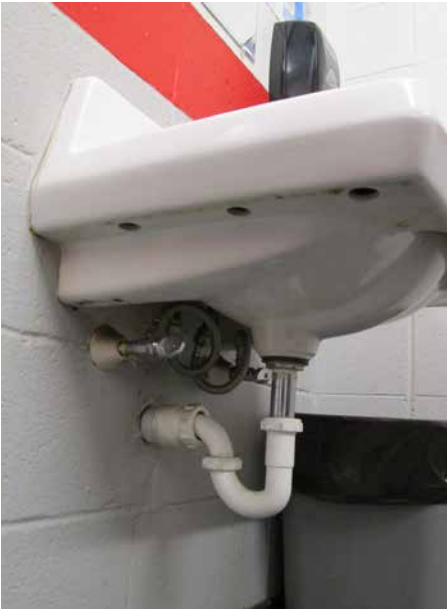
MISSING TRAP WRAP

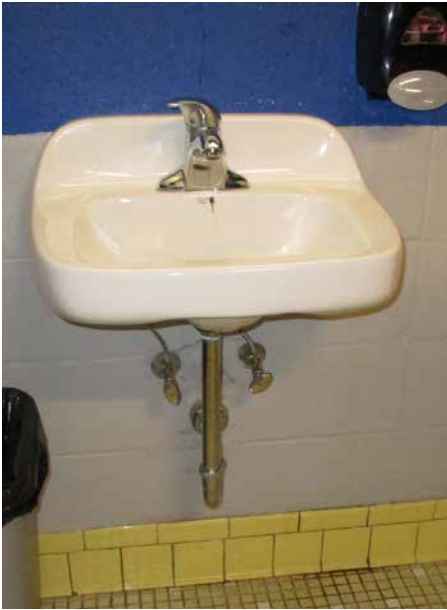
MISSING TRAP WRAP

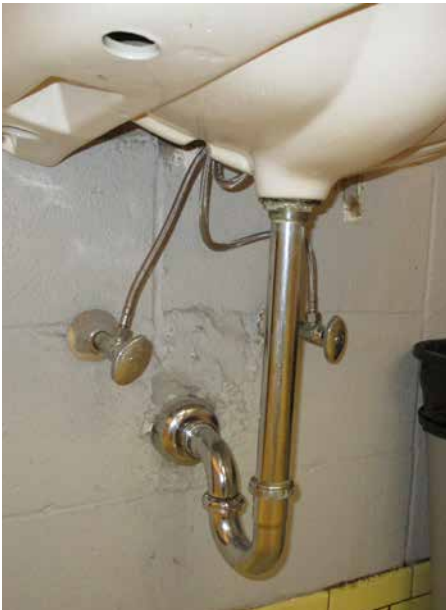
MISSING TRAP WRAP

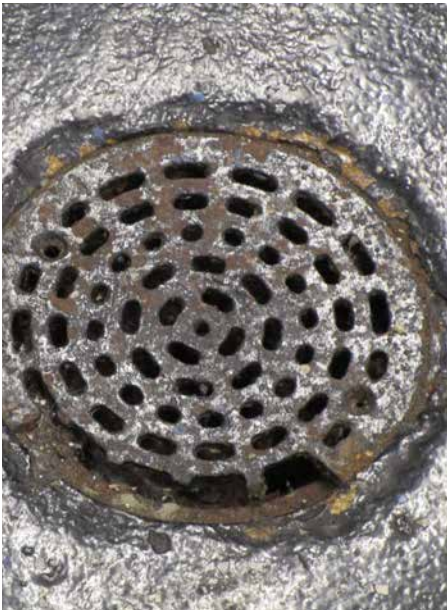
BROKEN FLOOR DRAIN GRATE

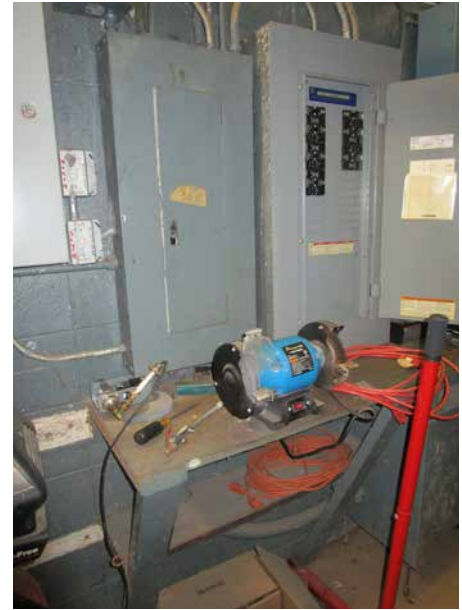
WORK BENCH CONFLICTS WITH  
WORKING SPACE OF BRANCH PANEL

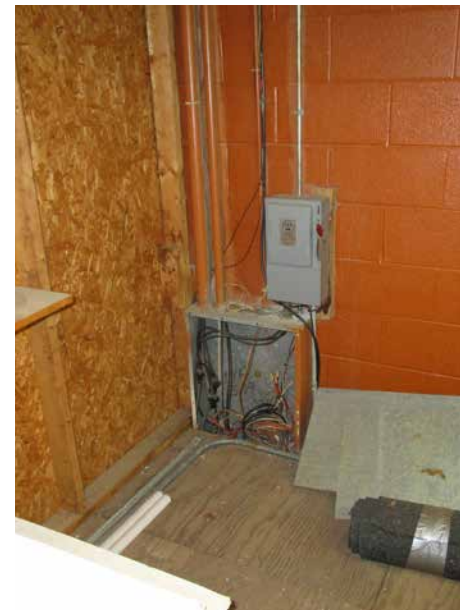
OPEN JUNCTION BOX
