January 16, 2025 Common Council
Meeting Minutes
Exhibit A

City of De Pere | De Pere Ice Arena

Facility Condition Assessment

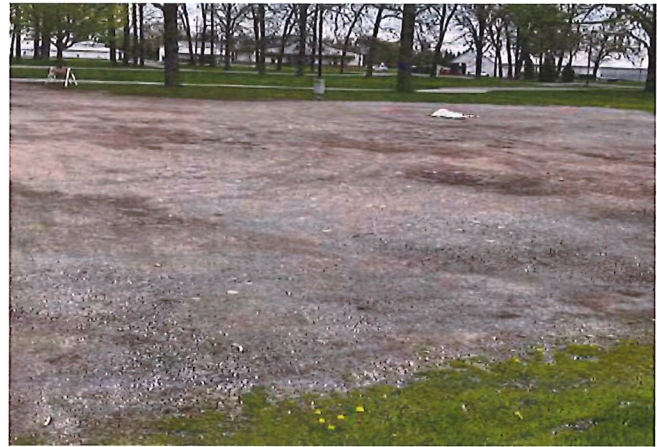
During boating season, competition for parking with boat launch users causes a lack of parking for ice rink events. Unless barricaded and signed "For Rink Use Only", at times boater traffic has occupied most of the parking areas for the rink, causing parking issues for rink users.

GRAVEL PARKING LOT EAST OF THE ARENA

- Install permanent signage displaying parking is for rink users only. Install an access control gate at the rear parking lot / service area. Regrade and pave the north and rear parking lot areas for drainage and striped parking, along with sidewalks to the main entrance and additional accessible stalls as required by code. Discussions with the southwest neighbor regarding tree and fence removal and replacement with a newer fence and screening plants is recommended as trees continue to decline.

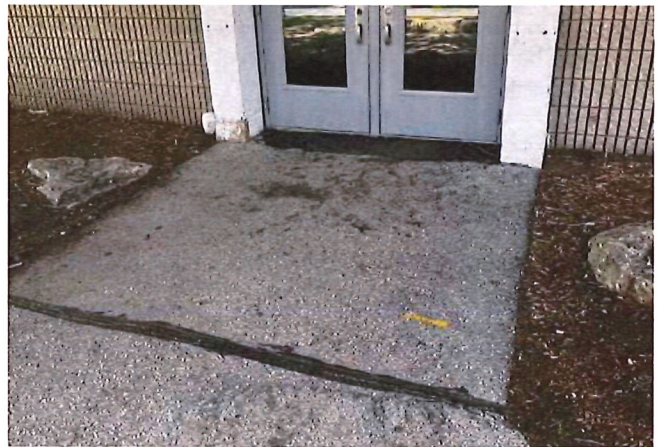
Around the building, there are 5 main egress doors with walks or concrete landings, along with several emergency exits discharging to gravel or grass. The entries have experienced settling of slabs or walkways, creating trip hazards and accessibility compliance issues. The main entry has been patched with asphalt as a temporary solution.

NO CONCRETE STOOP AT MAIN ENTRY

- Remove and Replace pavement at entries to create safe, flush access to doors. Recommend concrete sidewalks.

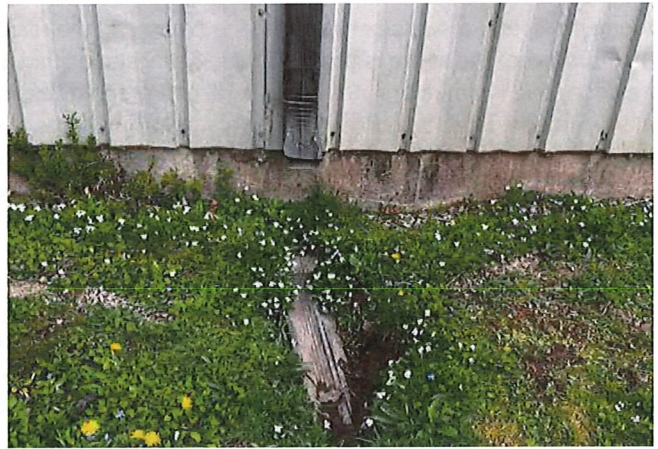
DOWNSPOUT WASHOUT

- Repair downspouts to gutter, add extensions, pipe stormwater away from building.

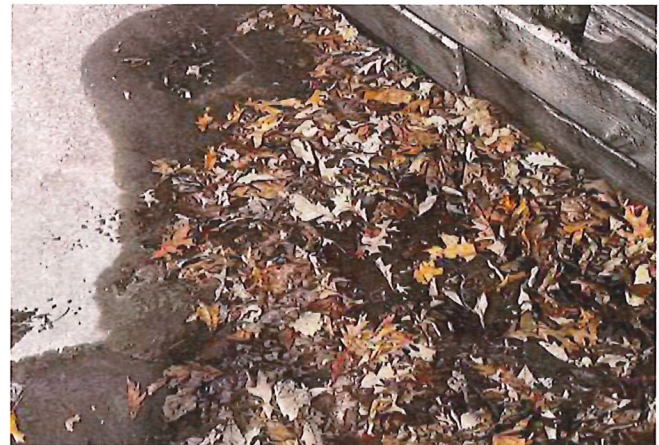
SURFACE DEBRIS

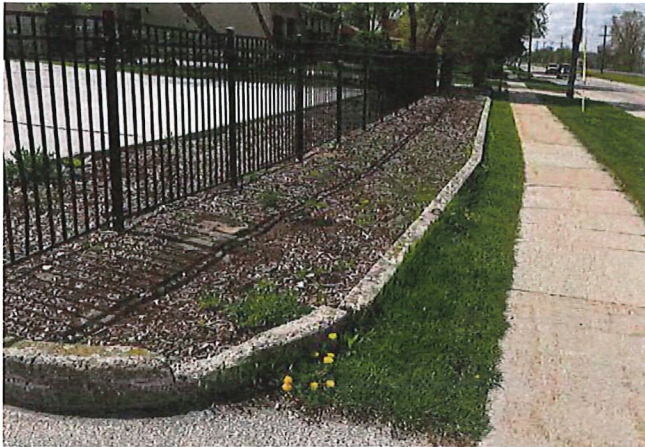
A front planting area with curbing and fencing exists along the Fort Howard Avenue frontage, and is in disrepair with cracked curbs, no vegetation, damaged 4-foot-tall fencing, and a damaged pedestrian gate to the sidewalk along Fort Howard

RETAINING CURB AT FORT HOWARD DRIVE

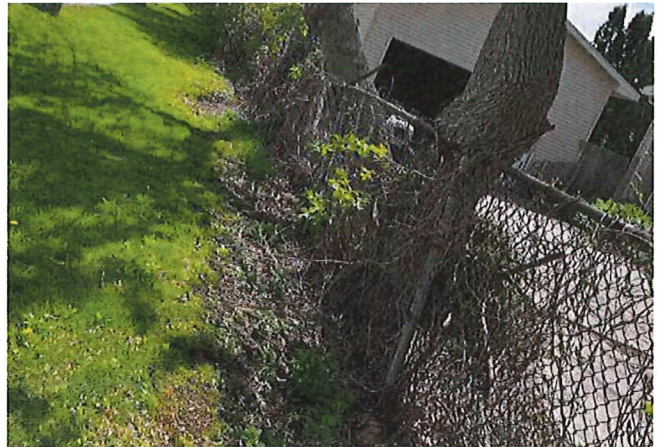
OVERGROWN TREES AT SOUTH PROPERTY LINE

Box elder trees on the south neighboring residential property at the Fort Howard Avenue frontage have grown into and damaged the existing chain link fence along the south property line. Many of the trees are in poor condition and lean over the property line onto the facility property. The operator mentioned that several times debris, limbs, and entire trees have fallen into the parking lot and required removal.

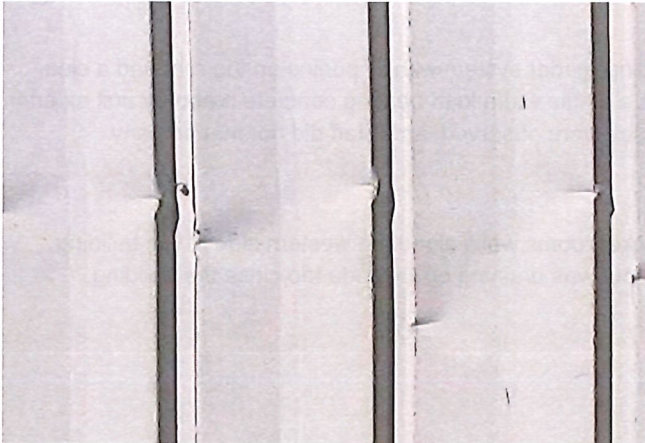
- The metal siding shows areas of buckling where it's either been hit, or the foundation has settled. The folds created are now starting to rust.
- At the base of some siding panels, the screw connections have rusted completely through the siding, and no longer hold the panel in place.
- Gaps in the metal siding, at the base of the wall, could easily allow rodents to enter into the insulation cavity, gaining access into the building.
- Gaps at the top of a few metal siding panels appear to have allowed birds or bats to construct nests in the insulation cavity.
- The jagged nature of the split face concrete masonry units allows dirt to accumulate and create streaks down the face of the walls.
- The heavily textured, white painted stucco also allows dirt to accumulate and contributes to the "old and dirty" feel of the exterior.

CRIMPED METAL SIDING AT ARENA BASE

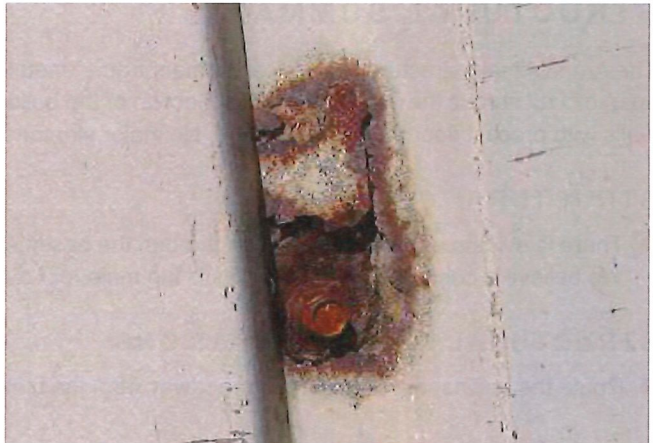
METAL SIDING CONNECTION RUSTED THROUGH

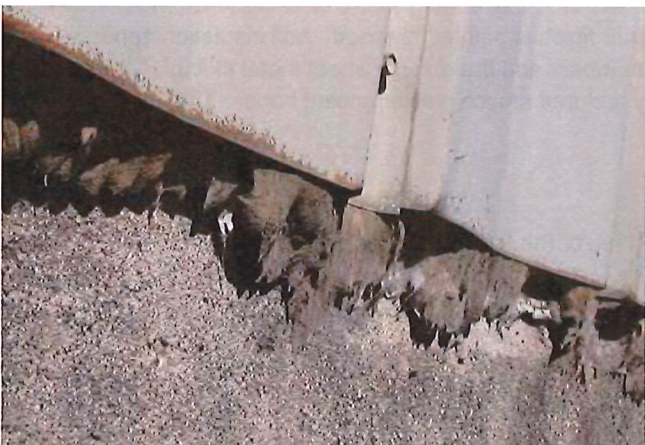
EXPOSED WALL INSULATION AT WALL BASE

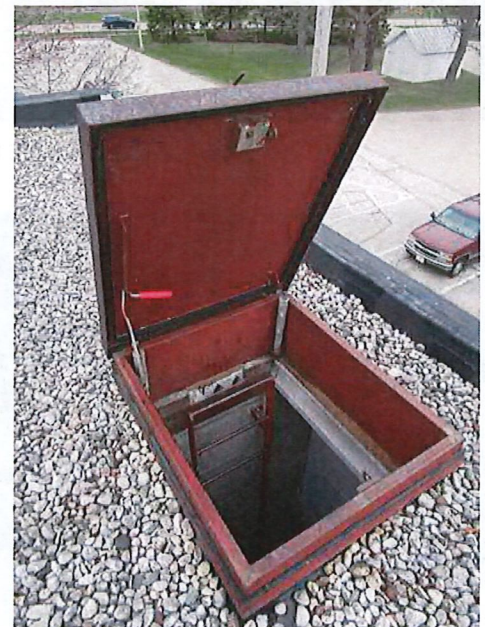
- The roof hatch cover is rotated 180 degrees from where it should be relative to the access ladder. This is a major safety concern for maintenance staff accessing the roof. This opening is directly against a roof edge.
- The adjacent honey locust tree deposits it's seed pods onto the roof. This organic material will break down and promote other organic material to grow between the ballast stones.
- At the Ice Plant area, the black layer of roofing membrane is held in place by the roofing ballast and is not continuous over the tan layer. It has exposed edges which will allow water to seep under it and become trapped.

ROOF HATCH INSTALLED BACKWARDS

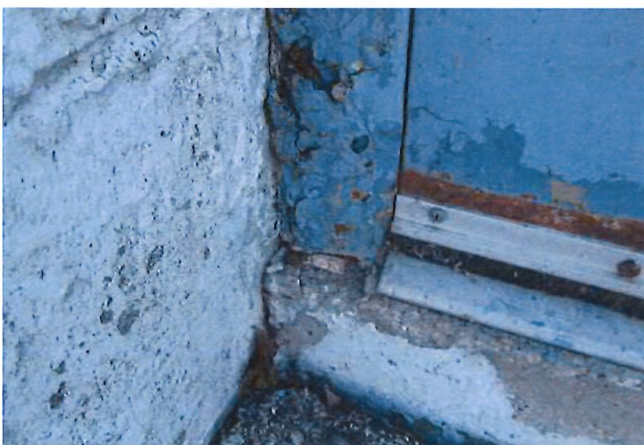
EXTERIOR METAL DOOR FRAME RUSTING

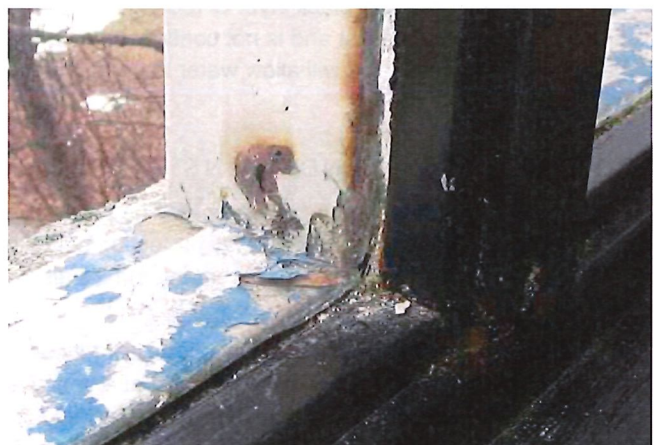
METAL WINDOW FRAME RUSTING FROM THE INSIDE

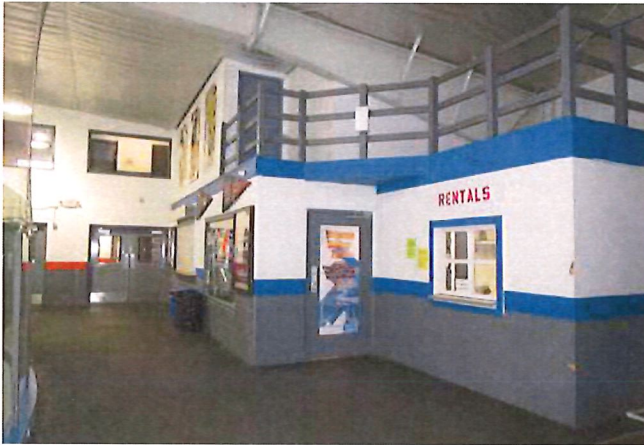
WOODEN STORAGE ROOM ABOVE CONCESSIONS

- Remove storage rooms, or construct a fire rated wall assembly at the 2nd floor storage rooms.

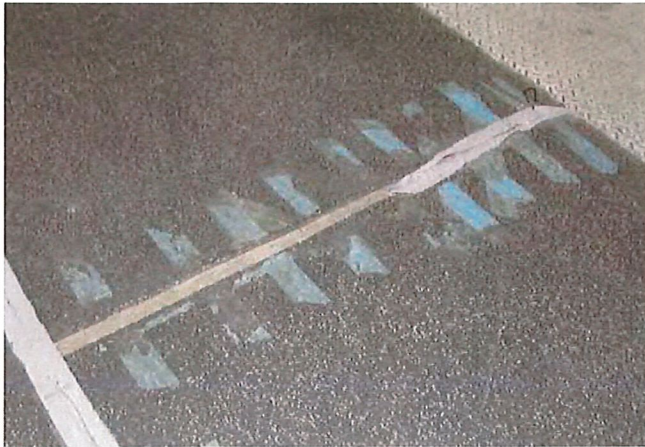
GAPS IN THE RUBBER FLOORING

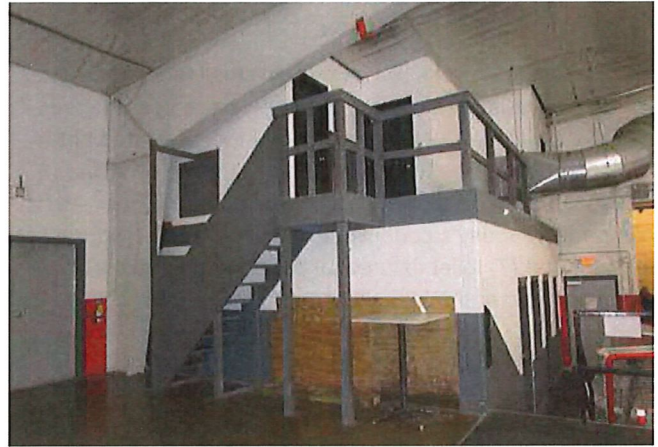
- Above the Team Rooms, there is a similar set of stairs leading to the dehumidification equipment surrounded by wooden walls. Again, the stairs and platform guardrails do not meet code.

WOODEN STAIRS TO DEHUMIDIFIER EQUIPMENT

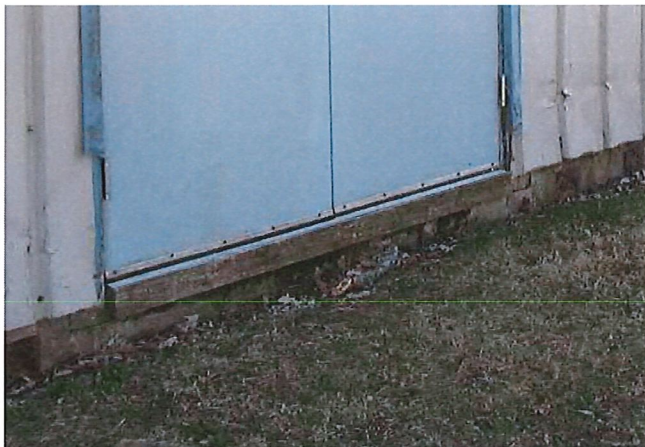
DROP OFF AT EXTERIOR EXIT DOOR

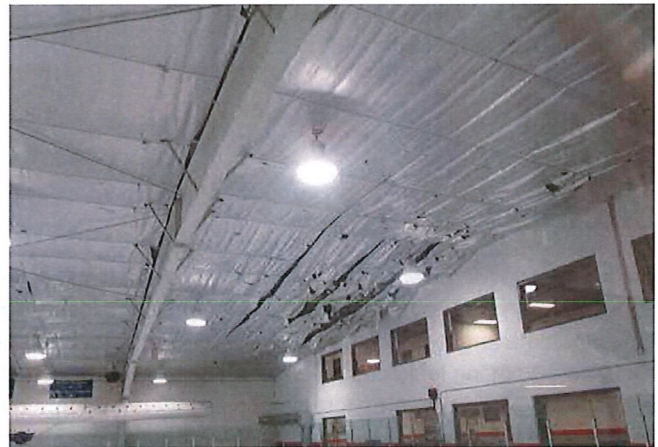
- There is a foil faced insulation below the roof purlins. At the goal ends, the foil facing has been damaged apparently by impacts with hockey pucks.

REFLECTIVE MEMBRANE RIPPED BY PUCKS

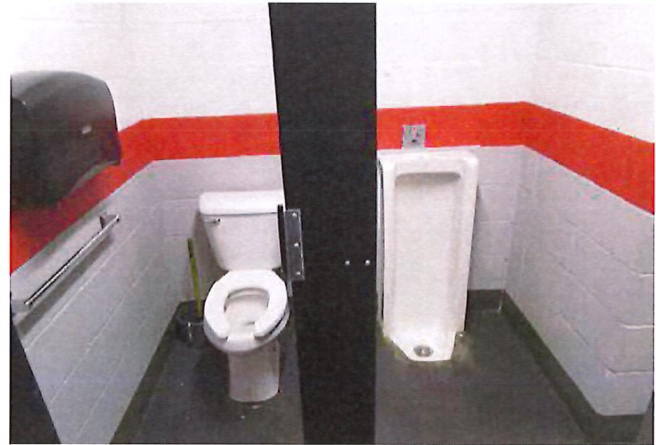
TYPICAL NON-ADA RESTROOM

- At least one ADA accessible toilet room should be constructed in the facility. Often single ADA toilet rooms are called out as Family Restrooms as they are private and big enough for wheelchairs, baby strollers and used by families with small children who can not use the regular restrooms.

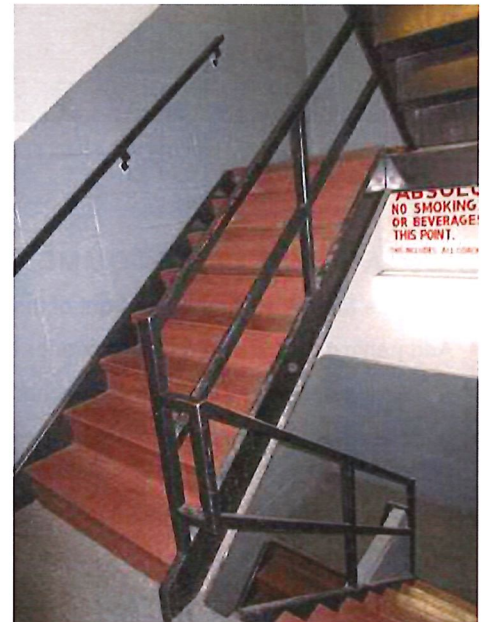
Existing stairways met code in 1974. Codes have changed over the years and the existing railings don't meet the code compliance for rails built today. Only a reconfiguration of more than 50% of the building would require these to be upgraded to current codes.

STAIR GUARD RAILS DO NOT MEET THE
CURRENT CODE

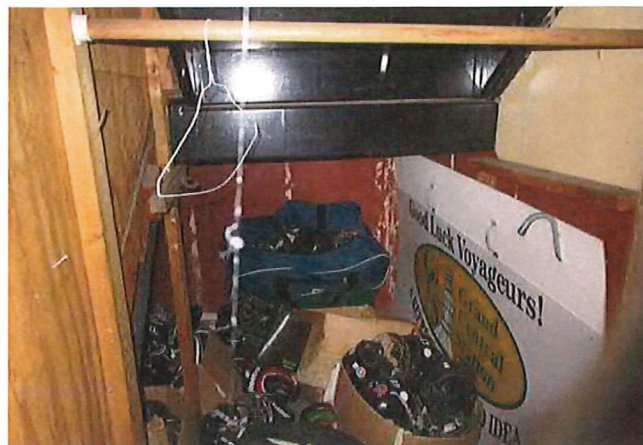
STORAGE UNDER EXIT STAIRWAYS

- All storage items and combustible construction under the stairs should be removed.

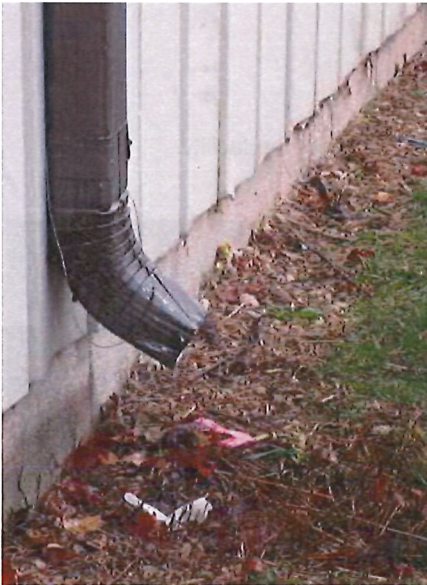
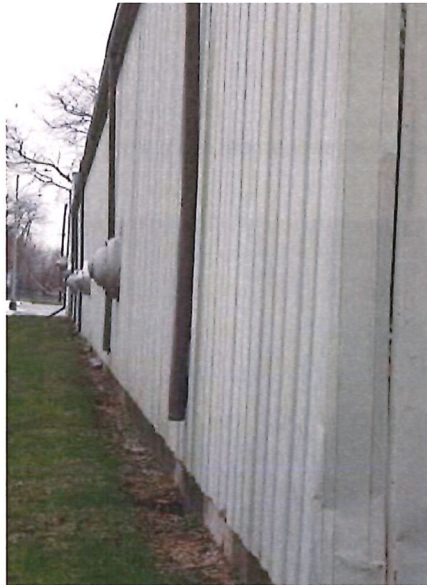
MISSING DOWNSPOUT EXTENSIONS

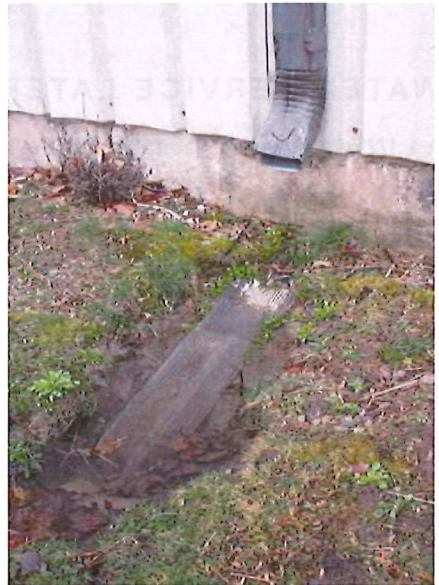
SEVERE PERIMETER GRADE EROSION

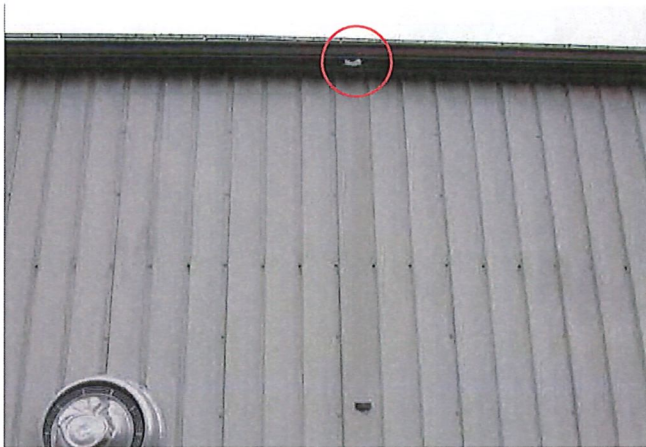
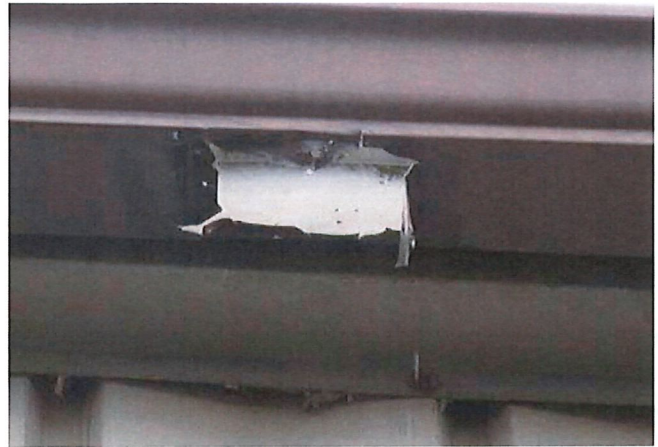
MISSING DOWNSPOUT

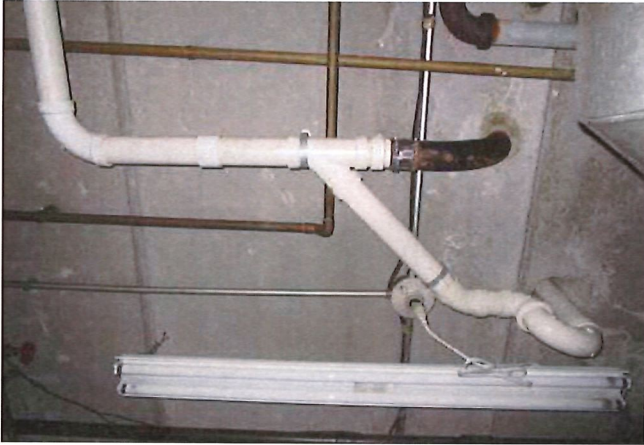
The original building was constructed in 1974. Condition of the entire system below floor is unknown. The above grade sanitary and vent piping is primarily cast iron with additions and repairs made in PVC.

REPAIRS IN PVC

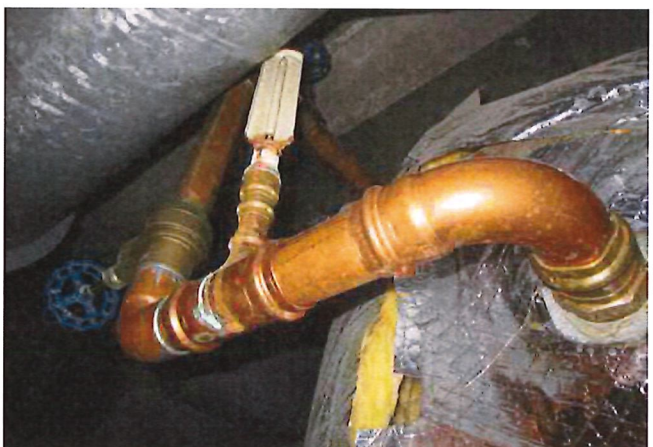
BROKEN THERMOMETER ON HOT WATER STORAGE TANK

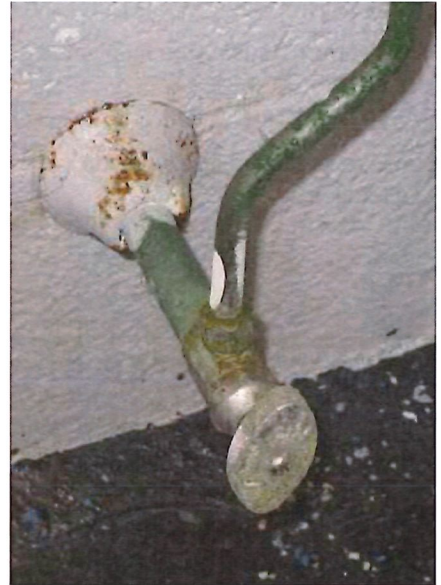
SUPPLY STOPS

All the waterclosets and lavatories were replaced in 2012 which puts them at 12 years old at the time of this report. Existing p-traps and supply stops appear to have been installed prior to 2012. Stops are corroded.

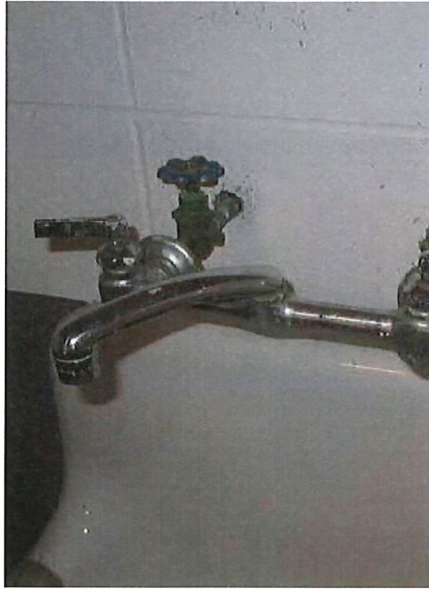
SERVICE SINK MISSING SUPPLY
SHUT-OFF VALVE HANDLES AND
VACUUM BREAKER

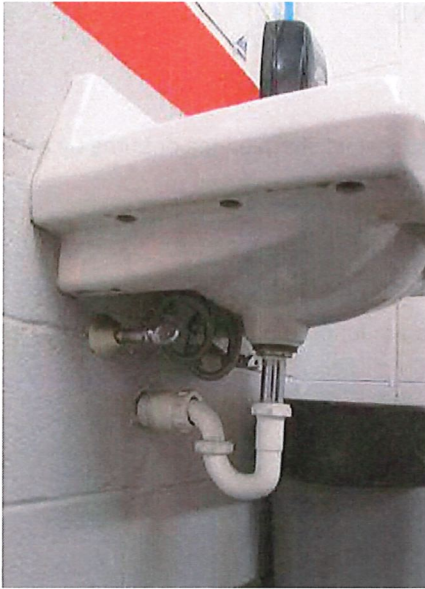
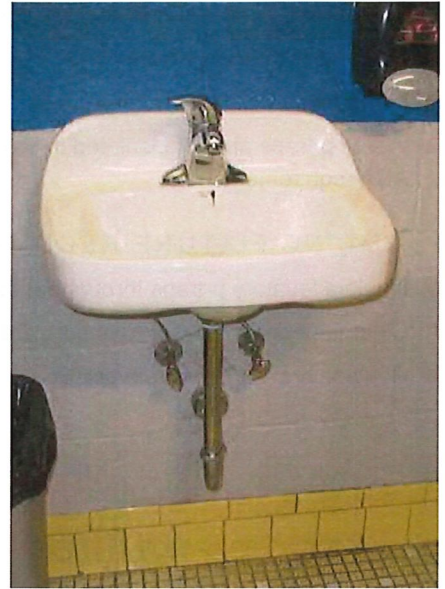
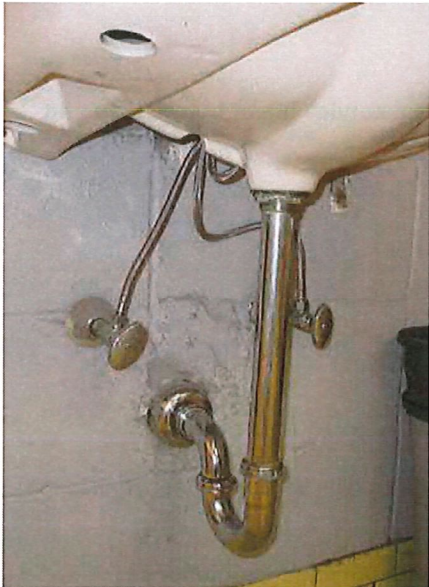
MISSING TRAP WRAP

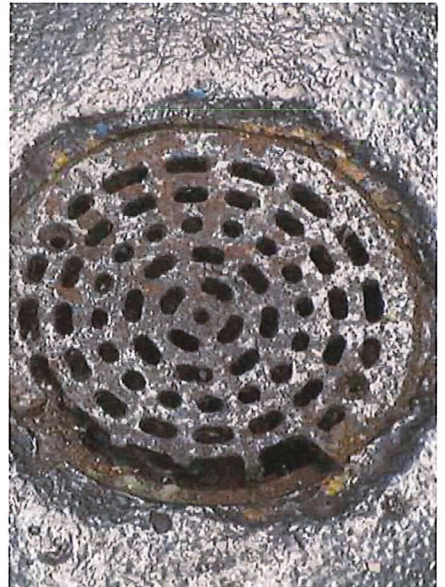
- Waterclosets are tank type. Supply stops are corroded.
- Lavatories are wall hung with manual faucets.
- One dual height electric water cooler with bottle filler (EWC) located at the first level is in good condition and meets ADA.
- Urinals are stall type with sensor operated flush valve and a manual flush valve on second level.
- The first level service sink is a molded basin with spout threaded on vacuum breaker. The second level has an older mop basin with a two-handle faucet and plain end spout. No vacuum breaker required since it is not a threaded outlet.
- Lavatory p-traps are missing trap wrap to meet ADA code requirements.
- Some floor drain grates are broken and/or clogged.

BROKEN FLOOR DRAIN GRATE

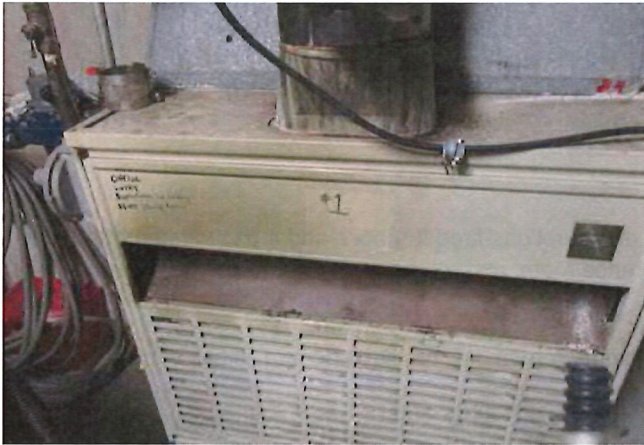
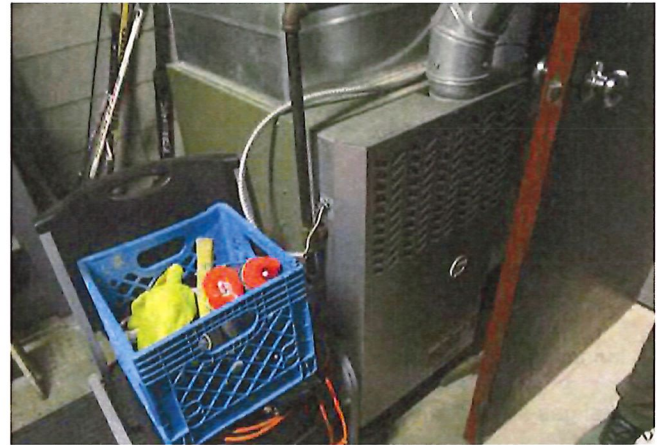
Equipment	Actual Equipment Age	ASHRAE Estimated Service Life ¹	Observed Condition
Gas-fired Furnaces	15-34 Years	18 Years	Poor
Packaged Rooftop Unit	25 Years	15 Years	Poor
Indoor Air Handling Unit with Coils	18 Years	20-25 Years	Fair
Inline Pump (Pipe Mounted)	18 Years	10 Years	Fair
Heat Exchangers (Shell-and-Tube)	18 Years	24 Years	Good
Gas-fired Infrared Heaters	1 Year	20 Years	Good
Gas-fired Unit Heater	5 Years	13 Years	Good
Powered Roof Ventilators	50 Years	20 Years	Poor
Electric Baseboard Heaters	50 Years	13 Years	Poor
Electronic Controls	2-25 Years	15 Years	Fair

- Implement a contingency plan to replace furnaces that have exceeded their estimated service life expectancy. Recommend replacement to be with sealed combustion, high efficiency, condensing furnaces.
- Consider replacing flue venting for unit heater.
- Consider replacing wood gas piping supports on roof with UV resistant rubber or plastic supports with Unistrut for pipe attachment.

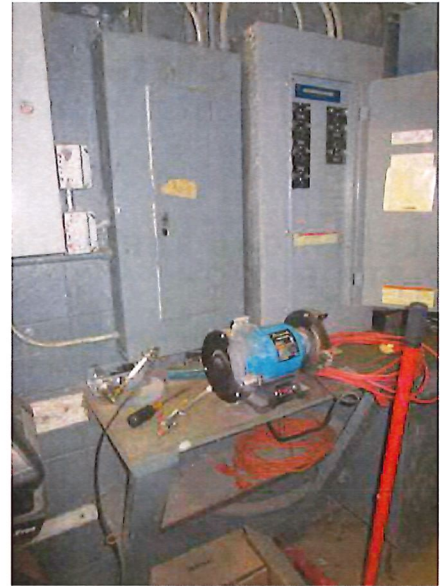
WORK BENCH CONFLICTS WITH
WORKING SPACE OF BRANCH PANEL

- Exercise each of the MDP breakers that feed the branch panels and equipment, to verify that they are functional and operate as required.
- Replace Main Distribution panel and breakers with new.
- Replace certain Branch panels with new.
- If the branch panels are replaced, the conductors feeding these panels should be replaced at the same time.
- Relocate branch panels that do not meet the required working space as defined by NEC 110.26. In the case of the panels in the Ice Plant; remove the workbench that conflicts with the working space.
- Electrical service equipment typically has a service life of approximately 30-40 years. The primary cause of the replacement is the inability to produce breakers which properly fit and operate within the existing branch and distribution panels toward the end of life.

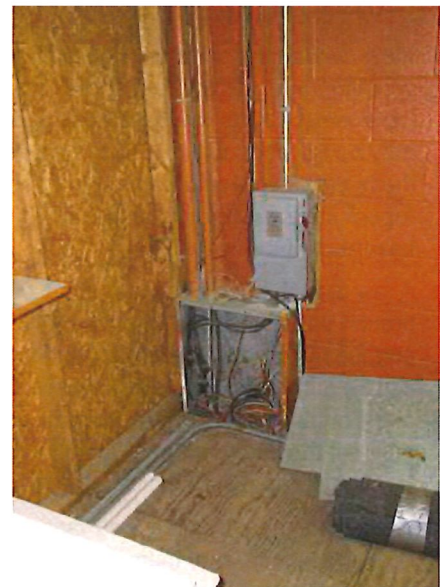
OPEN JUNCTION BOX
