JUNE 2024

# City of De Pere | De Pere Ice Arena

## Facility Condition Assessment

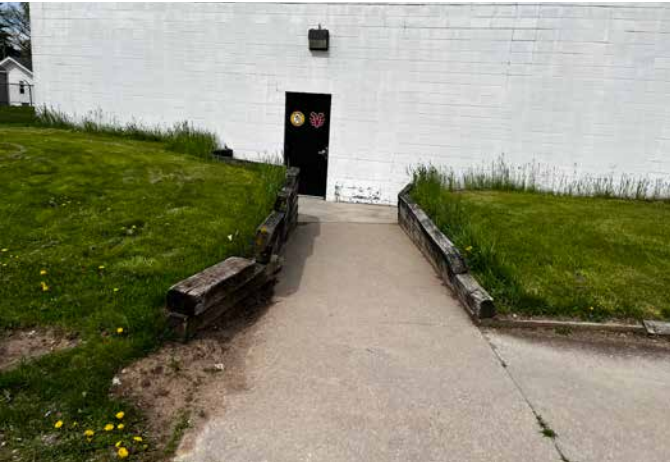
WOODEN RETAINER WALLS

At the rear of the building, several timber retaining walls adjacent to the rear locker room entry and Zamboni / mechanical / service area were observed in poor condition. The timber is rotted and past its life expectancy, and the walls have shifted and settled. The retaining wall adjacent to the mechanical / service room has shifted across the face of the service door.

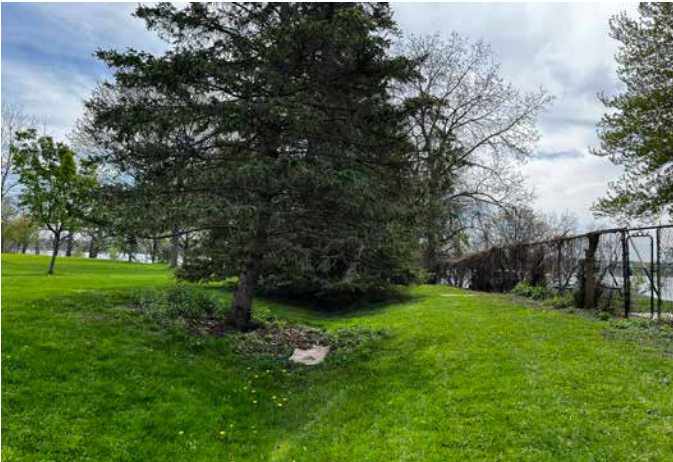
EAST DRAINAGE SWALE

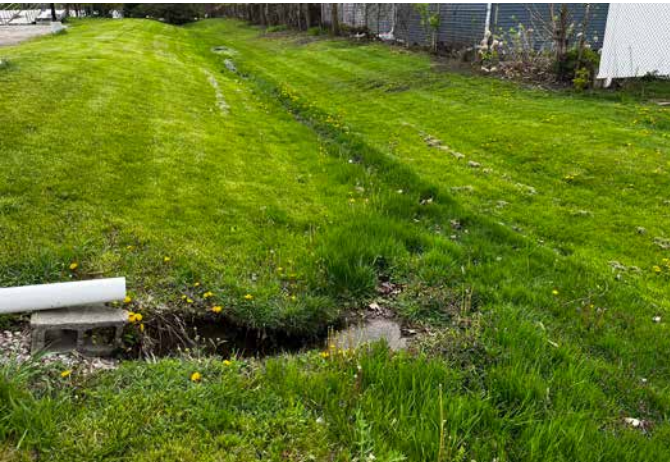
SOUTH DRAINAGE SWOLE

Along the south, a swale between the ice arena and the residential properties captures water and directs it east, towards the Fox River. The swale is graded at a minimal slope in some areas, causing wet pockets that are soft for mowers to traverse, and it meanders through several evergreen trees, inhibiting drainage and causing trash collection. Downspouts along the east façade drain into the swale, however years of damage from vandalism and maintenance mowing have left the downspouts in disrepair or missing all together. Some downspouts drain straight down against the building into the foundation, while others are heavily eroded adjacent to the building from discharge. Discharge from an internal roof drain for the rear locker room has caused significant erosion to the rear swale.

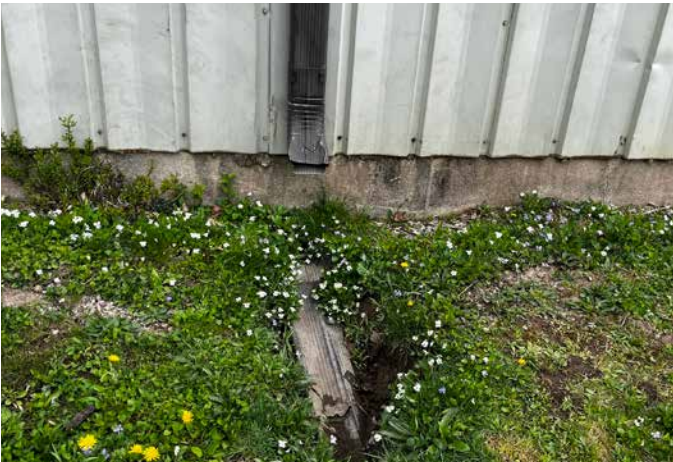
DOWNSPOUT WASHOUT

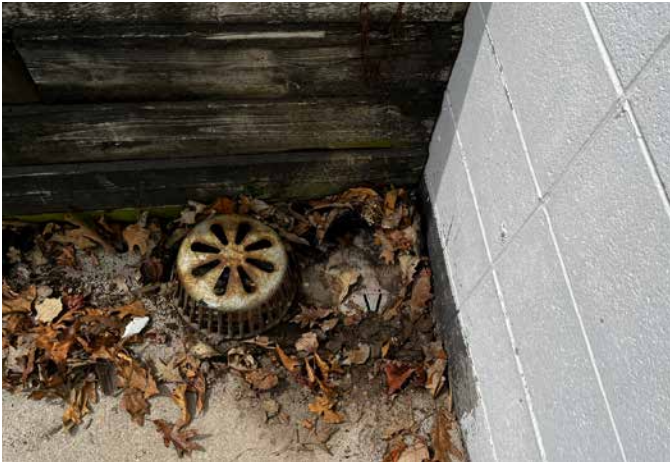
DEBRIS AT SURFACE DRAIN

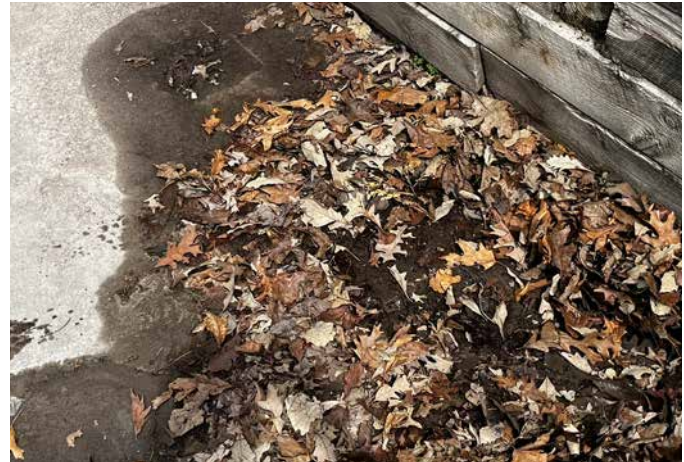
SURFACE DEBRIS

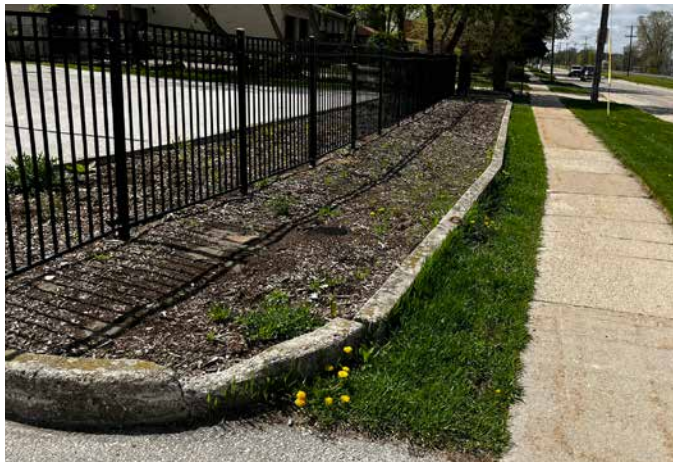
A front planting area with curbing and fencing exists along the Fort Howard Avenue frontage, and is in disrepair with cracked curbs, no vegetation, damaged 4-foot-tall fencing, and a damaged pedestrian gate to the sidewalk along Fort Howard

RETAINING CURB AT FORT HOWARD DRIVE

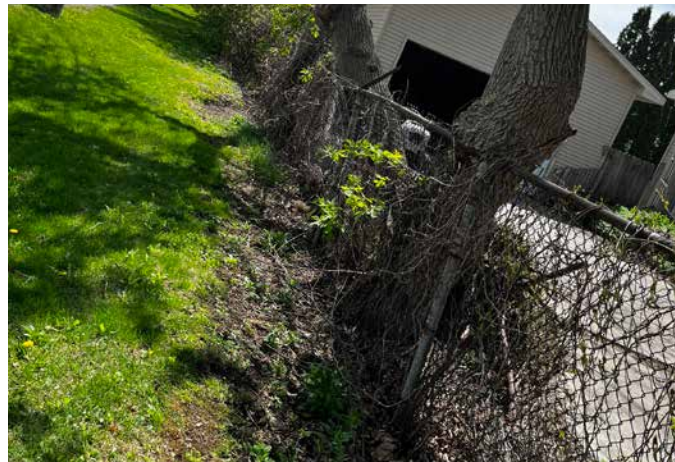
OVERGROWN TREES AT SOUTH PROPERTY LINE

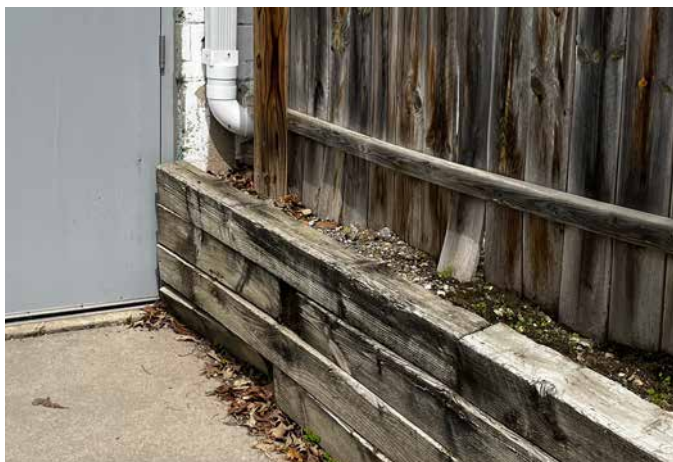
WOODEN RETNING WALL

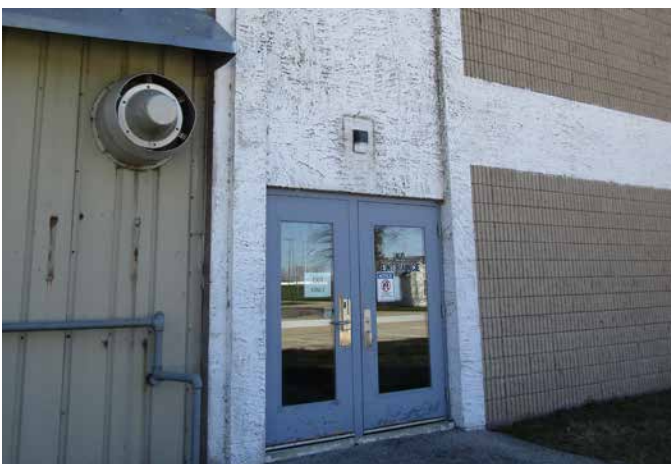
TEXTURED STUCCO HOLDING DIRT

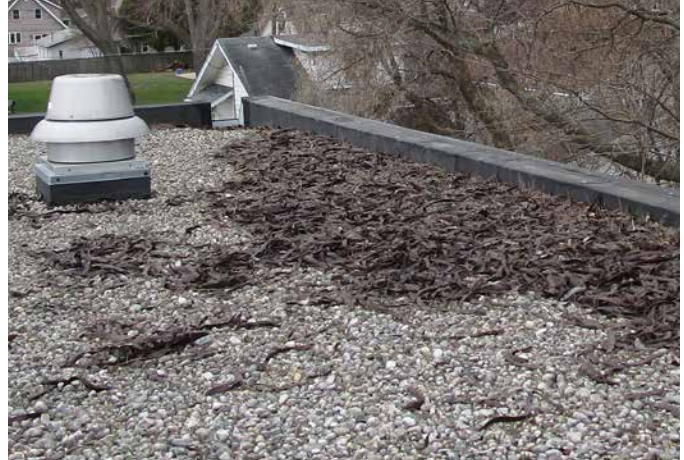
SEED PODS ON ROOF

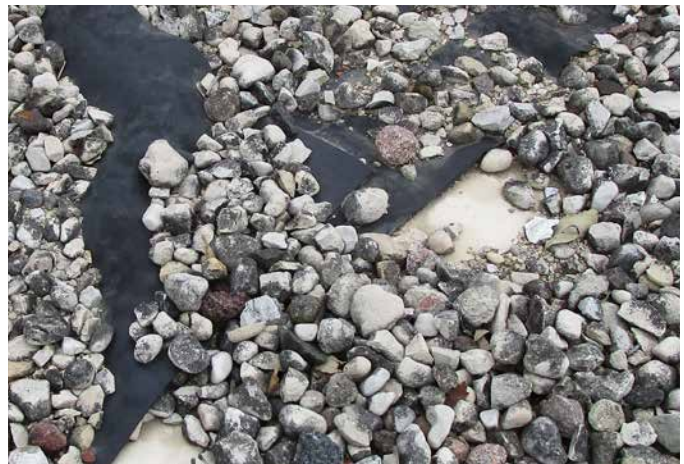
- It's not understood why the ice plant has effectively two roofing membranes. Our theory is that the new tan membrane is not very thick and is not attached to the insulation below. The black rubber membrane is heavy enough to support ballast stones which holds the roof in place. Again, we do not know why there are two membranes at this location.

ICE PLANT ROOF

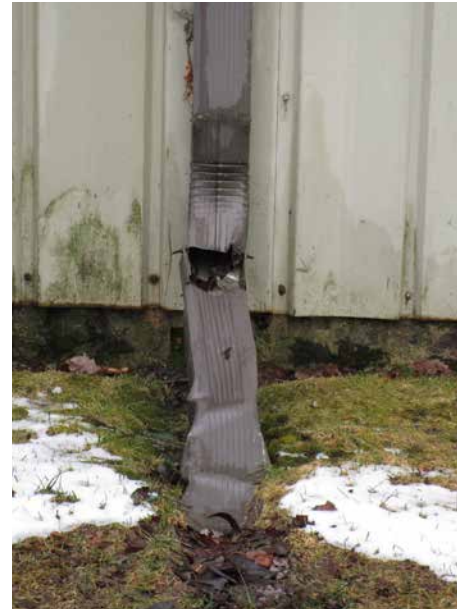
CRUSHED DOWNSPOUTS

- Repair downspouts to gutter, add extensions, pipe stormwater away from building.

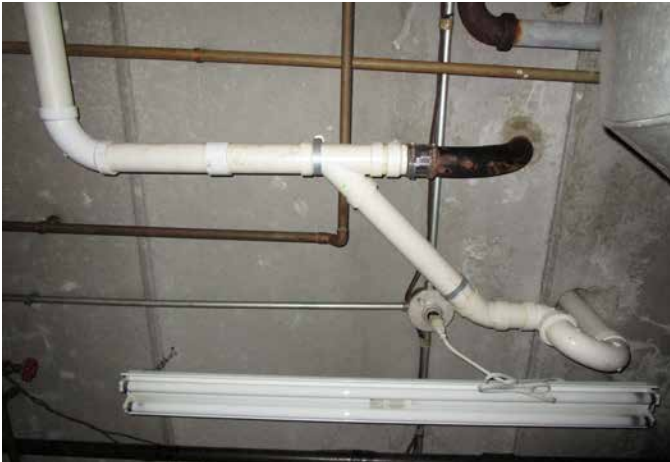
REPAIRS IN PVC

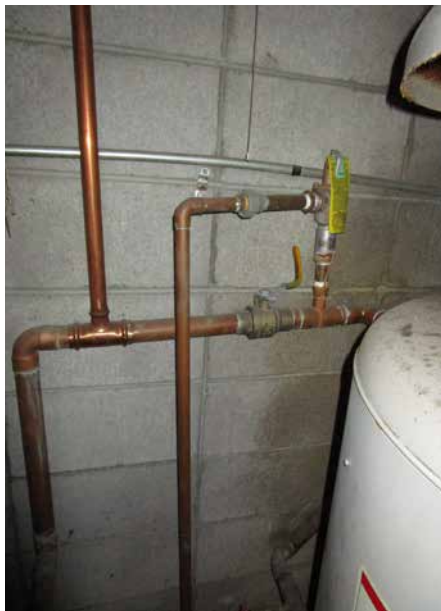
Hot and cold supply piping within the building is not insulated or labeled.

COPPER SUPPLY PIPING – NO  
INSULATION/NO LABELING

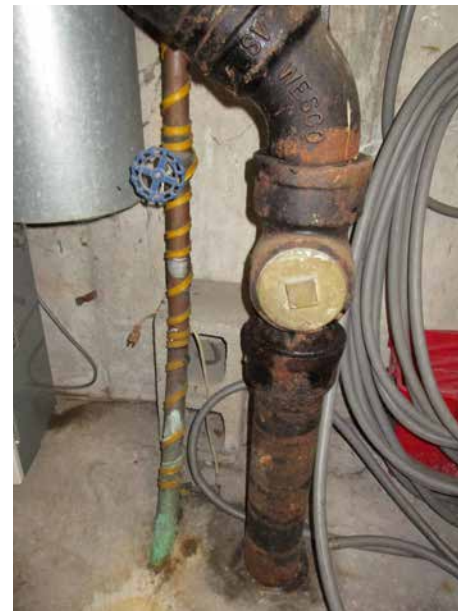
1 1/2" SUPPLY TO BELOW FLOOR –  
UNINSULATED/NOT LABELED  
AND HEAT TRACED

- Lack of recirculation piping at branches limits the availability of hot water to most fixtures without running them for extended periods of time.
- Supply piping should be fully insulated and labeled throughout the facility.
- Outlet supply pipe of storage tank has a broken thermometer.

- Per the Wisconsin Plumbing Code adoption, 2015, from the IECC (International Energy Conservation Code) effective May 1, 2018, regarding maximum pipe lengths on hot water supply to public lavatories and other fixtures by definition as being for public hand washing, shall provide hot water supply piping to within 2'-0" of the fixture for ½" supply pipe size. The entire hot water system would need updating/replacement to provide the necessary hot water at all hand washing fixtures to meet this code adoption.
- Insulate and label domestic water supply
- Replace/repair thermometer at hot water storage tank outlet.

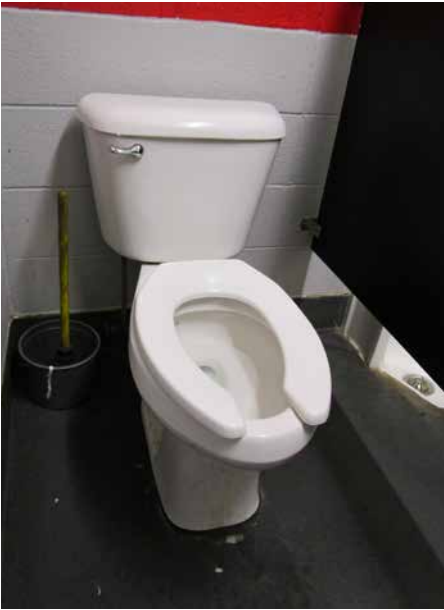
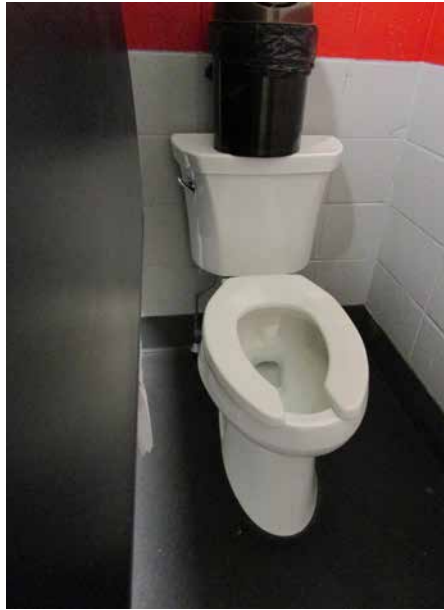
WATERCLOSETS REPLACED 2012

All the waterclosets and lavatories were replaced in 2012 which puts them at 12 years old at the time of this report. Existing p-traps and supply stops appear to have been installed prior to 2012. Stops are corroded.

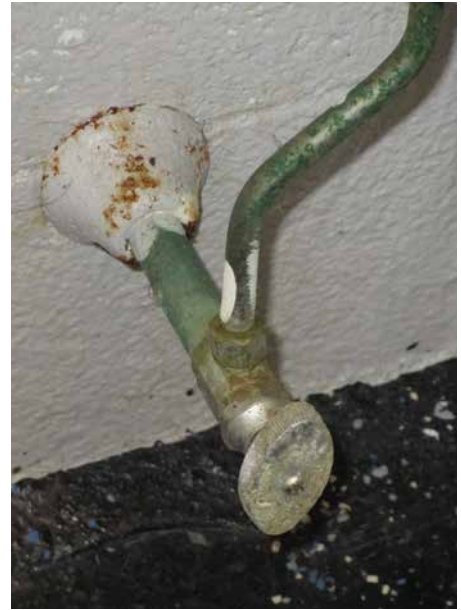
SUPPLY STOPS

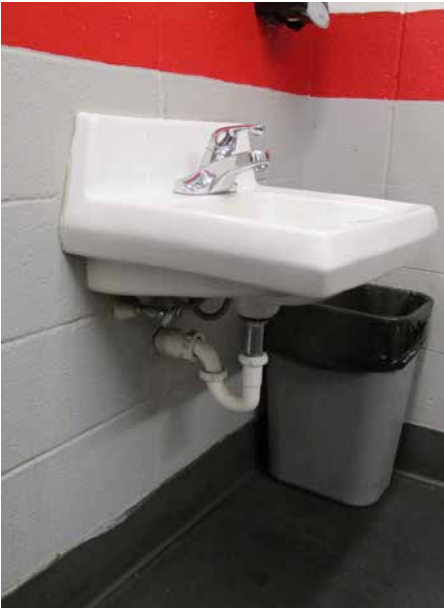
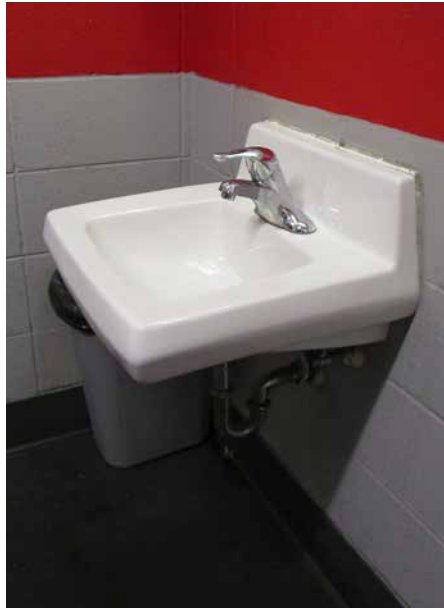
WALL HUNG LAVATORIES

- Clogged floor drain grates.
- Floor drains missing grates.
- Waste p-traps are not insulated to protect against sharp edges or burns by a wheelchair bound individual not meeting ADA requirements.

- Insulate lavatory p-traps throughout the facility to meet ADA.
- Clear floor drain gates and ensure drains are functioning properly.
- Replace broken floor drain grates.

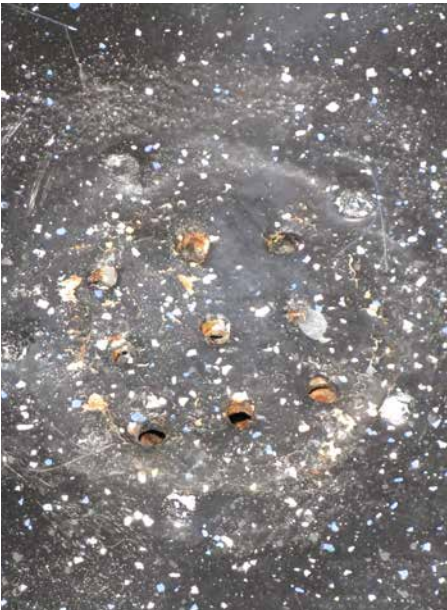
SHOWER ROOM FLOOR DRAIN GRATE

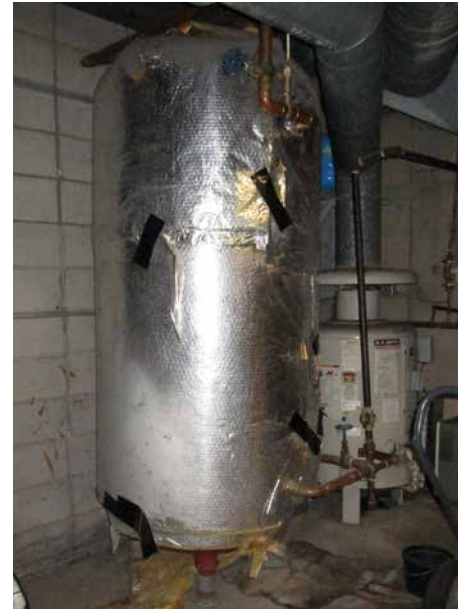
- Age of water heater and storage tank are exceeding normal service life and efficiency is in question.
- Storage tank has torn insulation blanket and condition of tank interior is in question
- Recirculation pump appears to be in good condition.

WATER HEATER/STORAGE TANK

- Replacement of water heater and storage tank is recommended due to age, questionable efficiency, and overall condition.

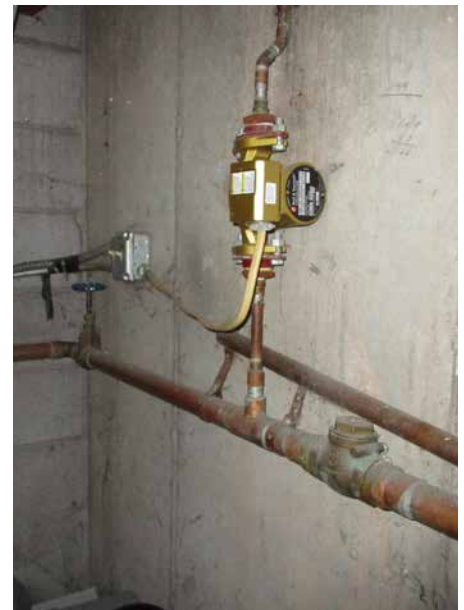
RECIRCULATION PUMP

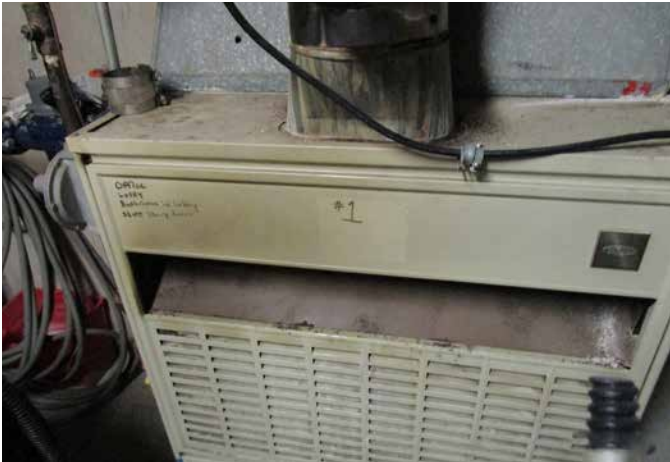
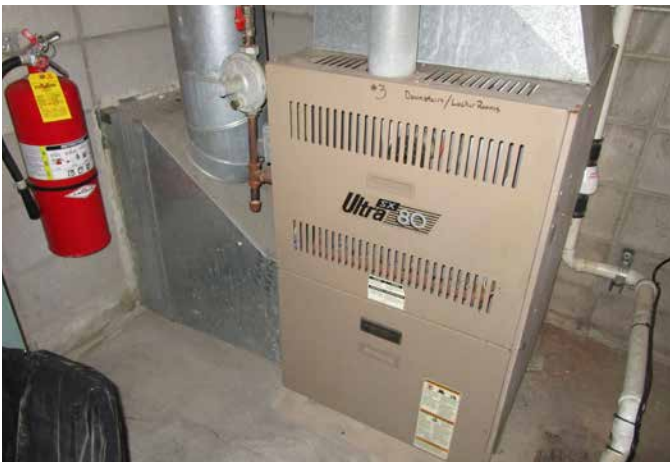
FURNACE #1

- Furnace #1 and #3 are well past their estimated service life expectancy, according to American Society of Heating, Refrigerating and Air-conditioning Engineers (ASHRAE). Furnace #2 is nearing its estimated service life expectancy. Due to age, maintenance can be expected to increase further.

- Implement a contingency plan to replace furnaces that have exceeded their estimated service life expectancy. Recommend replacement to be with sealed combustion, high efficiency, condensing furnaces.
- Consider replacing flue venting for unit heater.
- Consider replacing wood gas piping supports on roof with UV resistant rubber or plastic supports with Unistrut for pipe attachment.

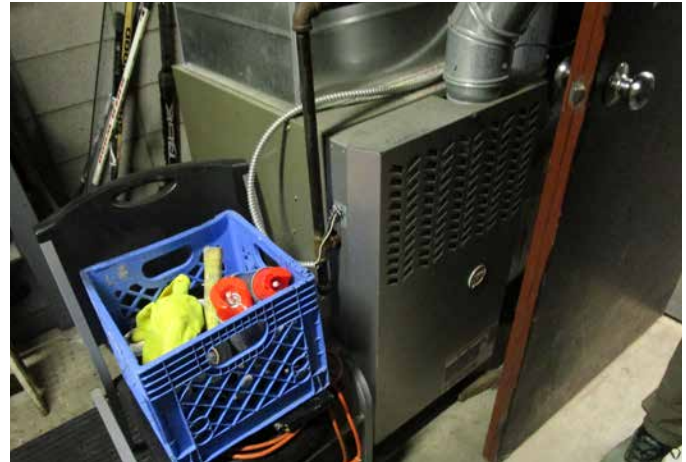
FURNACE #2

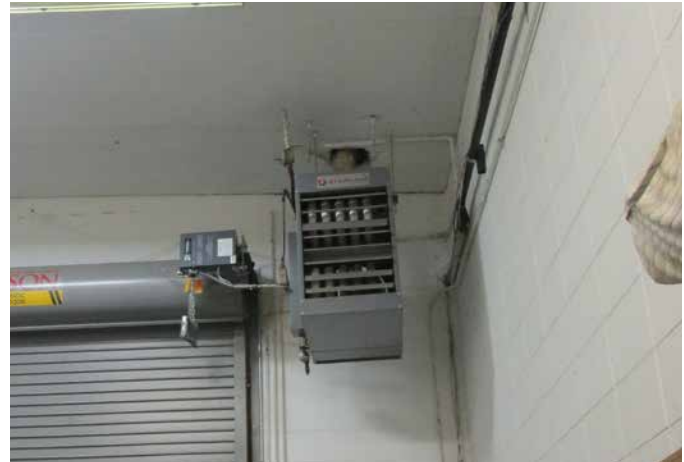
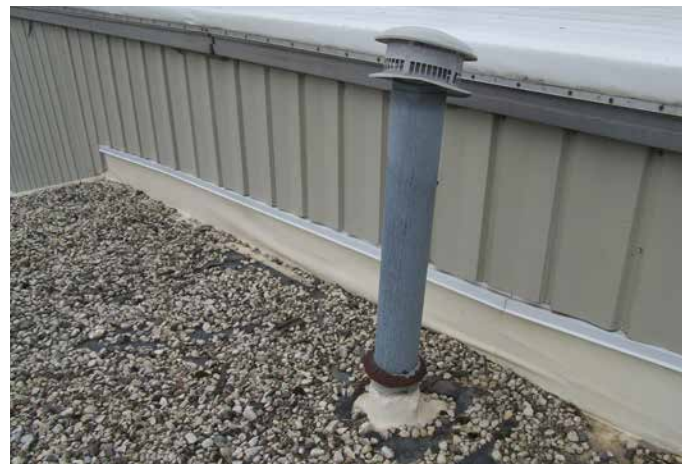
- Electric baseboard heaters are well past their estimated service life. Due to age, they could eventually fail to energize.
- When unit heater was replaced five years ago, existing venting was reused. Unit heater (low heat gas appliance) flue venting through roof is less than 10 feet horizontally from higher portion of building, so its vent termination should be installed a minimum of 2 feet higher than taller portion of building. When unit heater was replaced less than five years ago, venting should have been addressed to comply with Fuel and Gas Code.

UNIT HEATER FLUE VENT

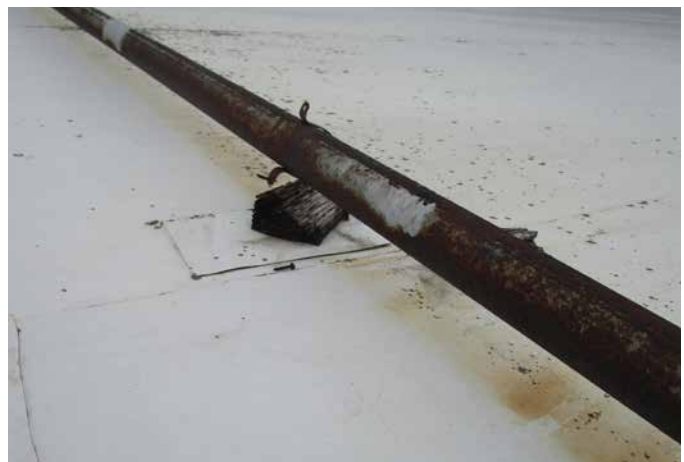
- Gas piping routed on Ice Arena roof is rusted and supported by rotten wood blocks. Improperly supported piping could cause damage to roof. The gas piping feeds units serving the east building addition utilized by Voyagers and Deacons teams.

GAS PIPING ON ROOF

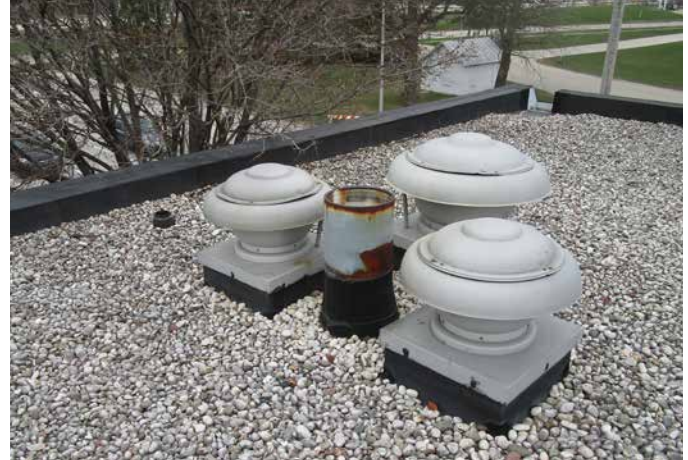
- Common flue venting termination on roof for furnaces does not have a rain cap. Venting inside the Basement mechanical room housing the furnaces is rusted and deteriorated. Openings in venting caused by deterioration may allow spread of harmful flue gases (carbon monoxide) into building.

POWERED ROOF VENTILATORS AND  
COMMON FURNACE FLUE VENT

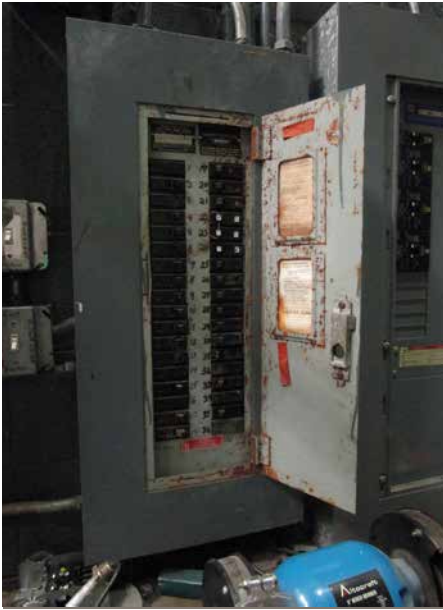
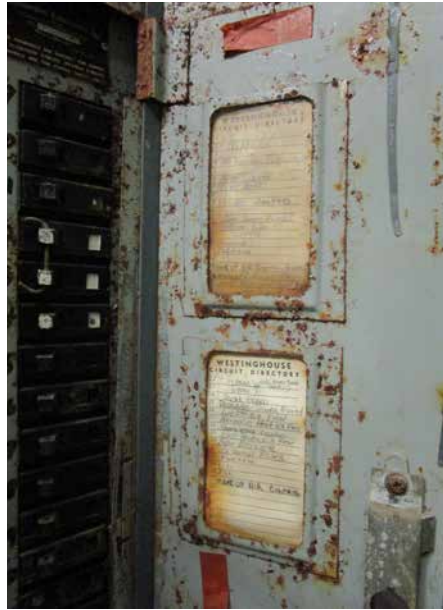
- The branch panels in the Ice Plant and Janitor’s Closet need to have clear floor space in front of them per National Electrical Code (NEC) 110.26 Working Space. There is a work bench in front of the branch panels in the Ice Plant that impedes into the working space.

BRANCH PANEL

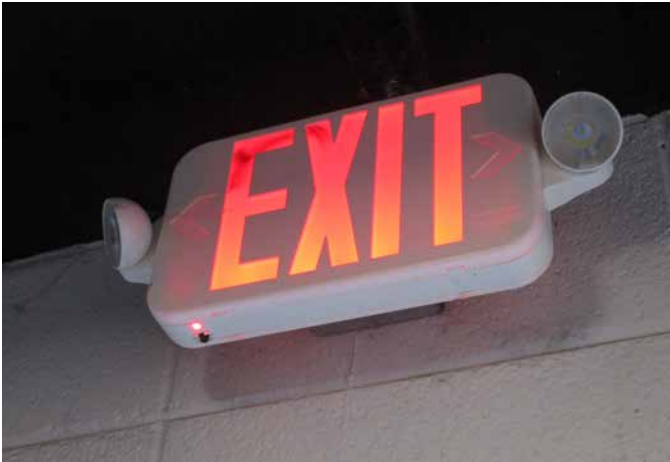
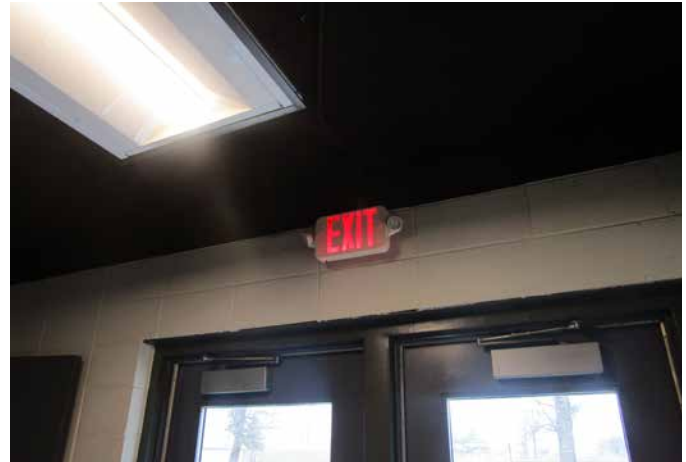
- Lack of automated controls such as occupancy sensors can result in energy over-usage. An occupancy sensor has the ability to automatically turn off luminaires in areas when unoccupied. The International Energy Conservation Code (IECC), Chapter 4, section C405 requires the use of automated controls.
- Although the exit signs have battery back-up lamp heads for emergency egress lighting, that may not be sufficient to cover the “path of egress” in all areas of the building. The “path of egress” is an unobstructed path to exit buildings or structures and shall be illuminated as required by the International Building Code (IBC), Chapter 10, Section 1008. This code requires illumination level of 1.0 footcandle at the walking surface and 10 footcandles in exit stairways.

EMERGENCY LIGHTING
