January 16, 2025 Common Council
Meeting Minutes
Exhibit A

City of De Pere | De Pere Ice Arena

Facility Condition Assessment

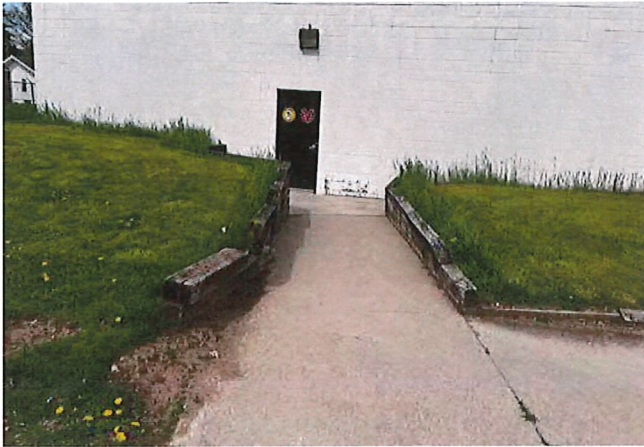
WOODEN RETAINER WALLS

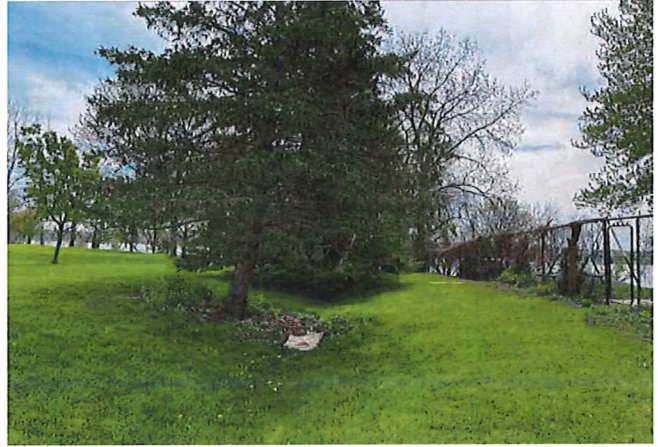
EAST DRAINAGE SWALE

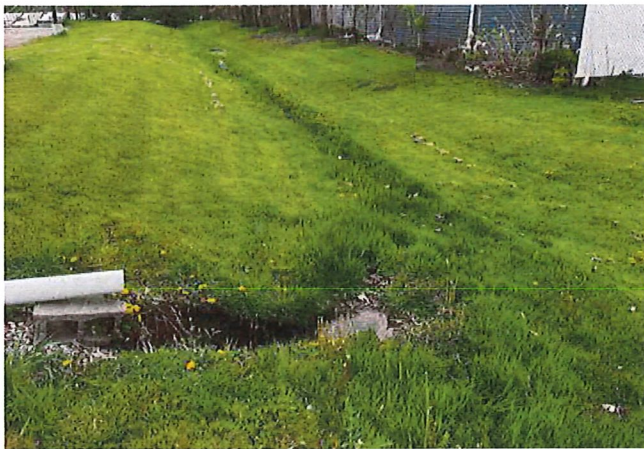
SOUTH DRAINAGE SWOLE

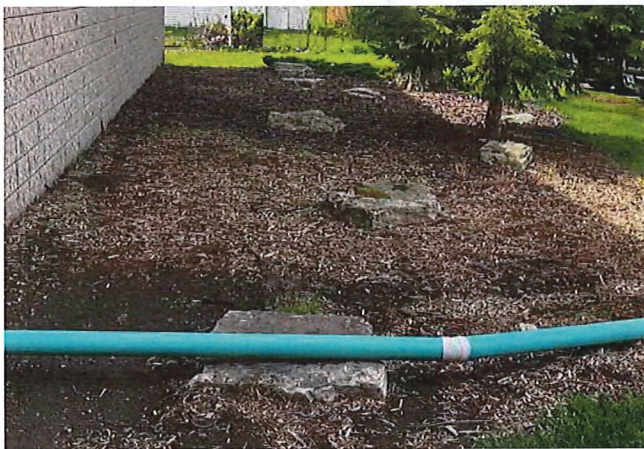
SURFACE ROOF DRAINAGE PIPE

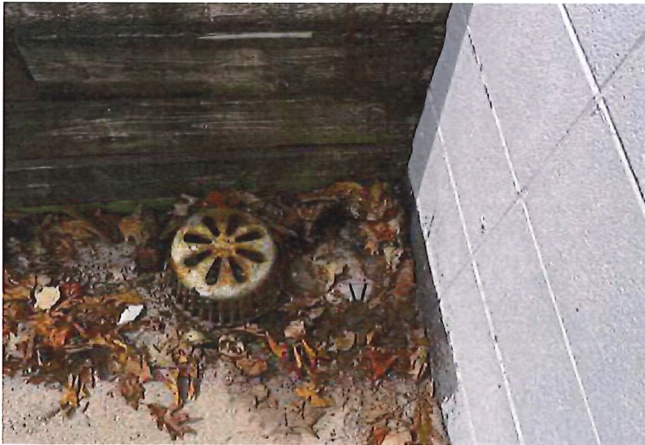
DEBRIS AT SURFACE DRAIN

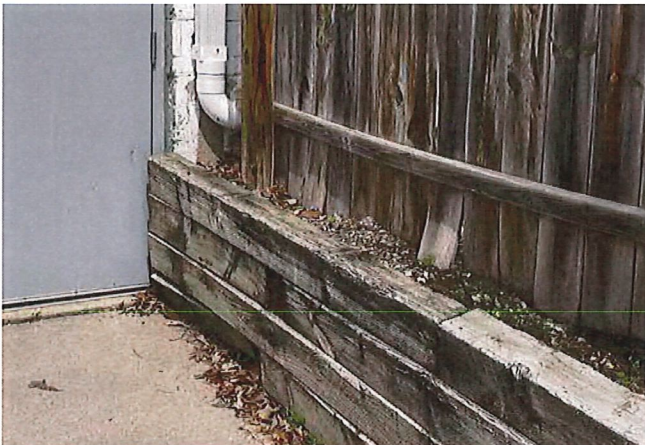
WOODEN RETNING WALL

At the rear of the building, several timber retaining walls adjacent to the rear locker room entry and Zamboni / mechanical / service area were observed in poor condition. The timber is rotted and past its life expectancy, and the walls have shifted and settled. The retaining wall adjacent to the mechanical / service room has shifted across the face of the service door.

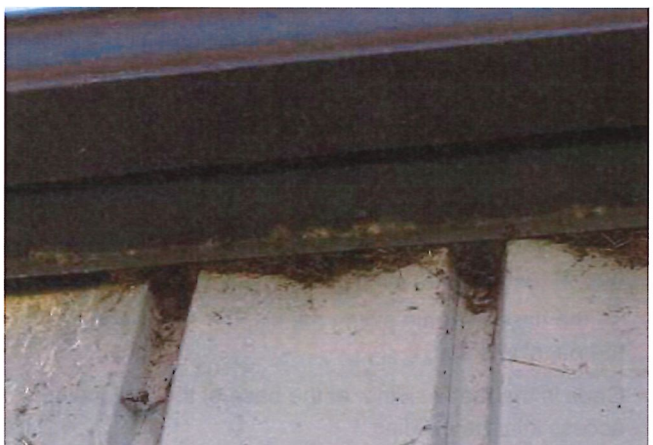
NEST IN SIDING GAPS UNDER THE ROOF GUTTERS

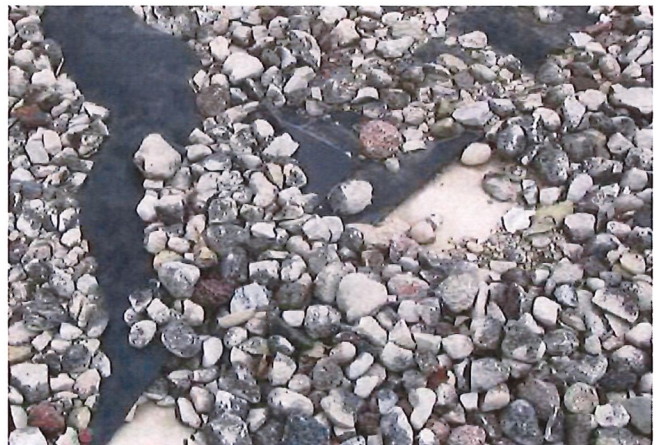
- It's not understood why the ice plant has effectively two roofing membranes. Our theory is that the new tan membrane is not very thick and is not attached to the insulation below. The black rubber membrane is heavy enough to support ballast stones which holds the roof in place. Again, we do not know why there are two membranes at this location.

ICE PLANT ROOF

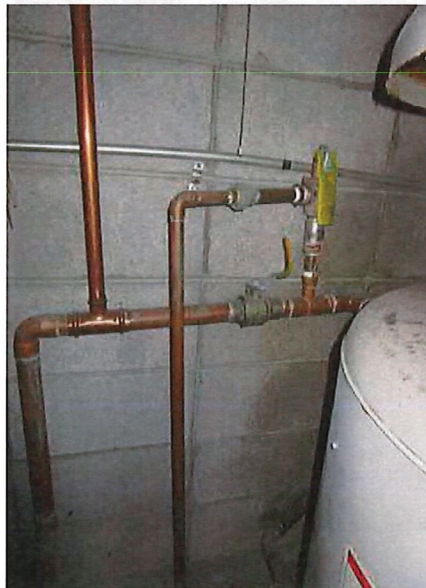
Hot and cold supply piping within the building is not insulated or labeled.

COPPER SUPPLY PIPING – NO INSULATION/NO LABELING

Condition of the entire sanitary system below floor is unknown and should be scoped to fully evaluate the condition. Supply piping needs to be insulated to help maintain temperature and reduce condensation. Updating the hot water recirculation piping system would increase hot water availability at hand wash lavatories and sinks. The hot water boiler and storage tank are beyond the expected service life and will require replacement in the near future. Plumbing fixtures that were upgraded in 2012 work as they should but the corroded p-traps and supply stops need eventual replacement.

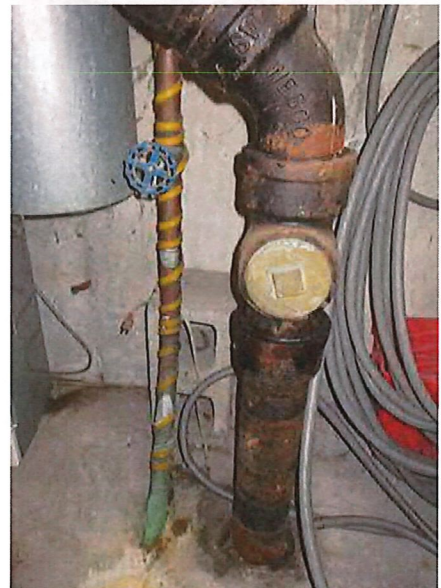
1 1/2" SUPPLY TO BELOW FLOOR – UNINSULATED/NOT LABELED AND HEAT TRACED

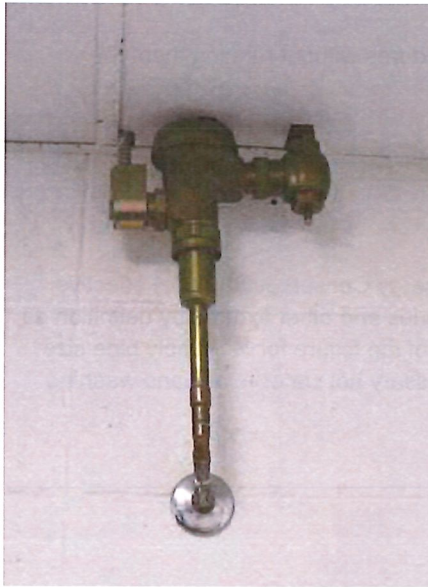
- Waterclosets are tank type. Supply stops are corroded.
- Lavatories are wall hung with manual faucets.
- One dual height electric water cooler with bottle filler (EWC) located at the first level is in good condition and meets ADA.
- Urinals are stall type with sensor operated flush valve and a manual flush valve on second level.
- The first level service sink is a molded basin with spout threaded on vacuum breaker. The second level has an older mop basin with a two-handle faucet and plain end spout. No vacuum breaker required since it is not a threaded outlet.
- Lavatory p-traps are missing trap wrap to meet ADA code requirements.
- Some floor drain grates are broken and/or clogged.

REMOTE URINAL FLUSH VALVE

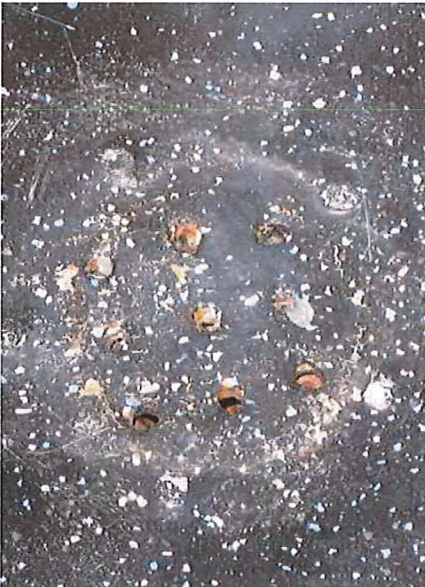
SHOWER ROOM FLOOR DRAIN GRATE

- Clogged floor drain grates.
- Floor drains missing grates.
- Waste p-traps are not insulated to protect against sharp edges or burns by a wheelchair bound individual not meeting ADA requirements.

- Insulate lavatory p-traps throughout the facility to meet ADA.
- Clear floor drain gates and ensure drains are functioning properly.
- Replace broken floor drain grates.

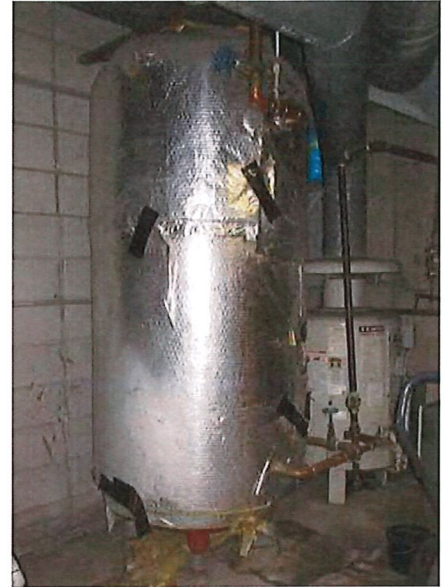
- Age of water heater and storage tank are exceeding normal service life and efficiency is in question.
- Storage tank has torn insulation blanket and condition of tank interior is in question
- Recirculation pump appears to be in good condition.

WATER HEATER/STORAGE TANK

- Replacement of water heater and storage tank is recommended due to age, questionable efficiency, and overall condition.

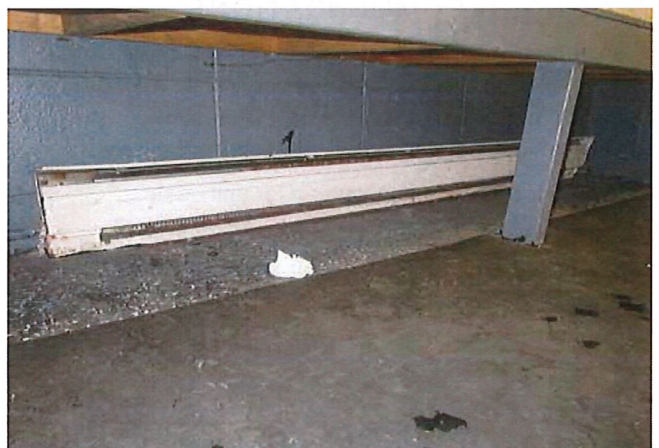
ELECTRIC BASEBOARD HEATER

- Electric baseboard heaters are well past their estimated service life. Due to age, they could eventually fail to energize.
- When unit heater was replaced five years ago, existing venting was reused. Unit heater (low heat gas appliance) flue venting through roof is less than 10 feet horizontally from higher portion of building, so its vent termination should be installed a minimum of 2 feet higher than taller portion of building. When unit heater was replaced less than five years ago, venting should have been addressed to comply with Fuel and Gas Code.

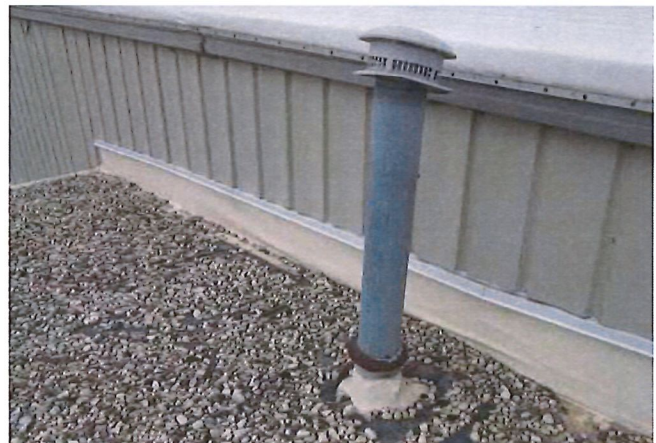
UNIT HEATER FLUE VENT

- Implement a contingency plan to replace furnaces that have exceeded their estimated service life expectancy. Recommend replacement to be with sealed combustion, high efficiency, condensing furnaces.
- Consider replacing flue venting for unit heater.
- Consider replacing wood gas piping supports on roof with UV resistant rubber or plastic supports with Unistrut for pipe attachment.

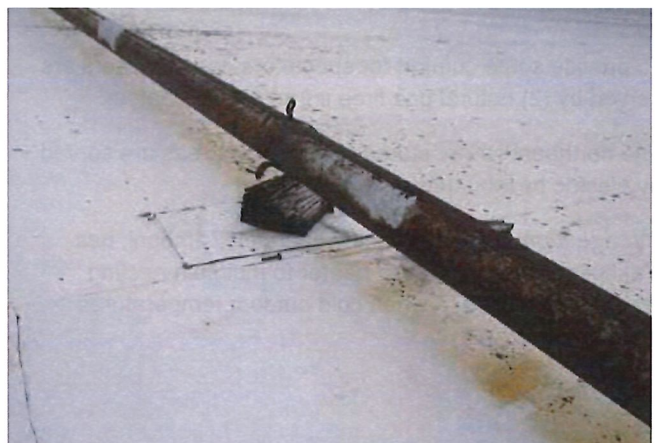
- Gas piping routed on Ice Arena roof is rusted and supported by rotten wood blocks. Improperly supported piping could cause damage to roof. The gas piping feeds units serving the east building addition utilized by Voyagers and Deacons teams.

GAS PIPING ON ROOF

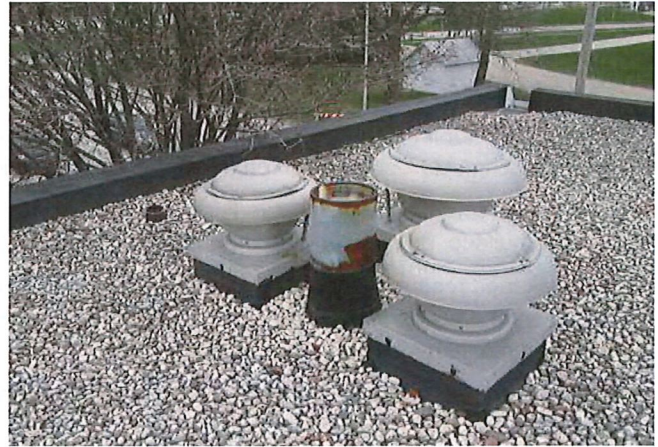
- Common flue venting termination on roof for furnaces does not have a rain cap. Venting inside the Basement mechanical room housing the furnaces is rusted and deteriorated. Openings in venting caused by deterioration may allow spread of harmful flue gases (carbon monoxide) into building.

POWERED ROOF VENTILATORS AND
COMMON FURNACE FLUE VENT

- If air-conditioning is desired in areas served by furnaces, recommendation is to add DX cooling coils to replacement furnaces. The coils would be piped with refrigerant to air-cooled compressor condensing units that could be mounted on the roof.
- Replace packaged rooftop unit.
- Replace aging powered roof ventilators for Restrooms, Showers and Locker Rooms.

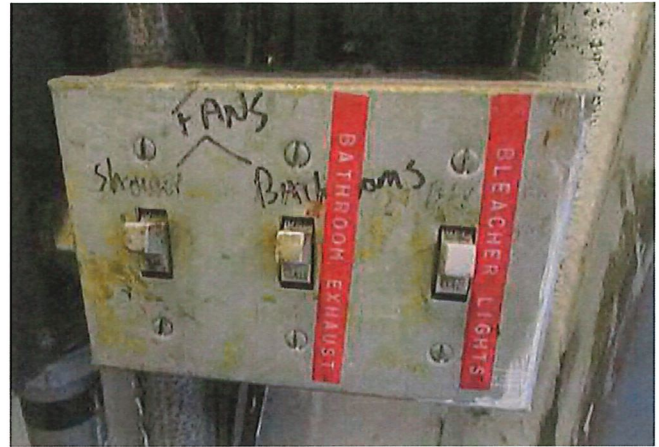
- Overall, control components have exceeded their estimated service life expectancy and should be replaced.

SHOWER AND RESTROOM FAN SWITCHES
