January 16, 2025 Common Council
Meeting Minutes
Exhibit A

City of De Pere | De Pere Ice Arena

Facility Condition Assessment

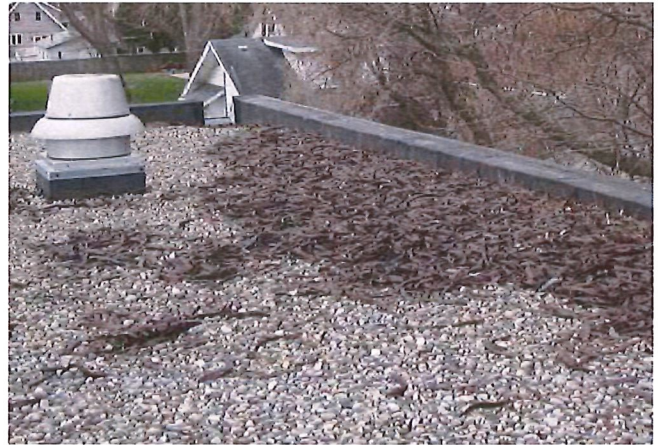
SEED PODS ON ROOF

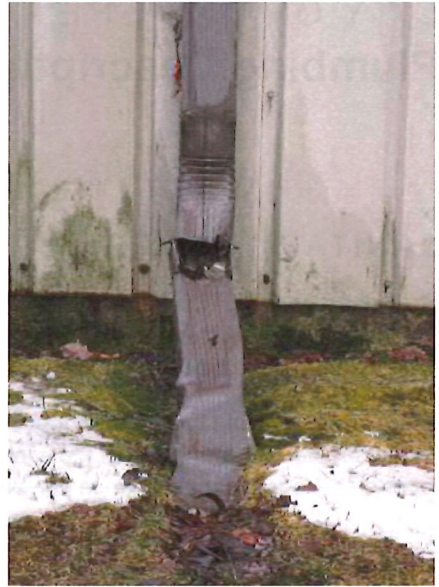
CRUSHED DOWNSPOUTS

- Repair downspouts to gutter, add extensions, pipe stormwater away from building.

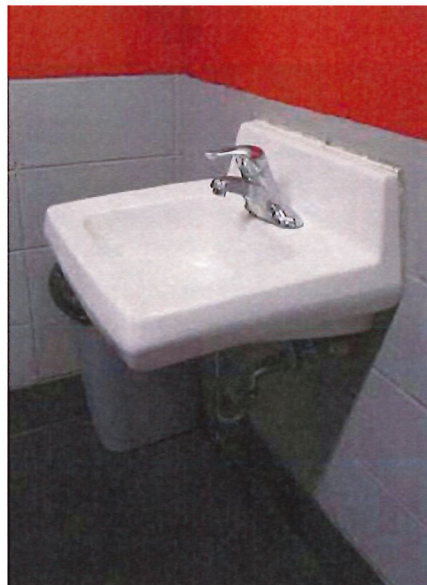
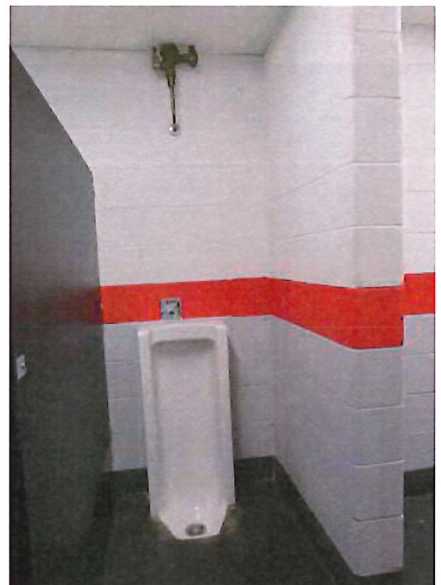
WALL HUNG LAVATORIES

- Waterclosets are tank type. Supply stops are corroded.
- Lavatories are wall hung with manual faucets.
- One dual height electric water cooler with bottle filler (EWC) located at the first level is in good condition and meets ADA.
- Urinals are stall type with sensor operated flush valve and a manual flush valve on second level.
- The first level service sink is a molded basin with spout threaded on vacuum breaker. The second level has an older mop basin with a two-handle faucet and plain end spout. No vacuum breaker required since it is not a threaded outlet.
- Lavatory p-traps are missing trap wrap to meet ADA code requirements.
- Some floor drain grates are broken and/or clogged.

- Insulate lavatory p-traps throughout the facility to meet ADA.
- Clear floor drain gates and ensure drains are functioning properly.
- Replace broken floor drain grates.

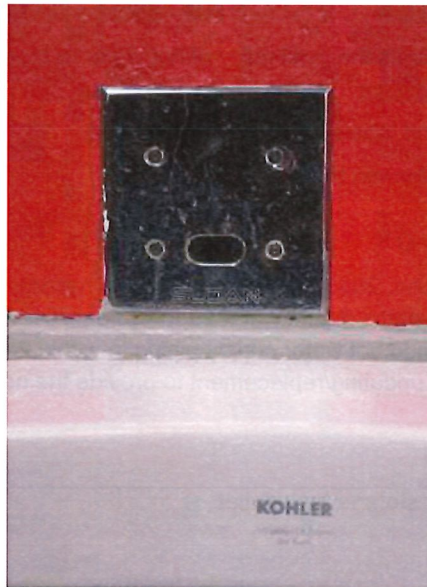
URINAL SENSOR OPERATED FLUSH

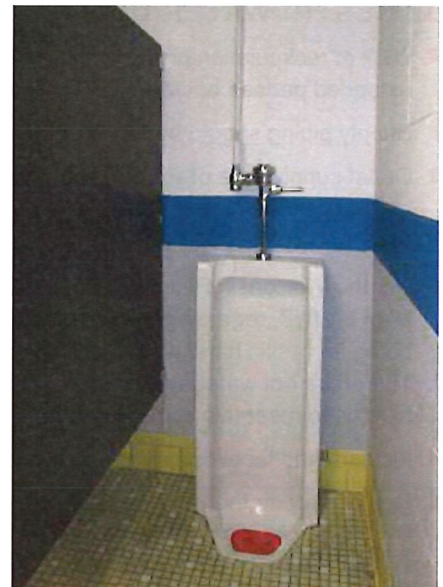
2ND LEVEL STALL URINAL
MANUAL FLUSH

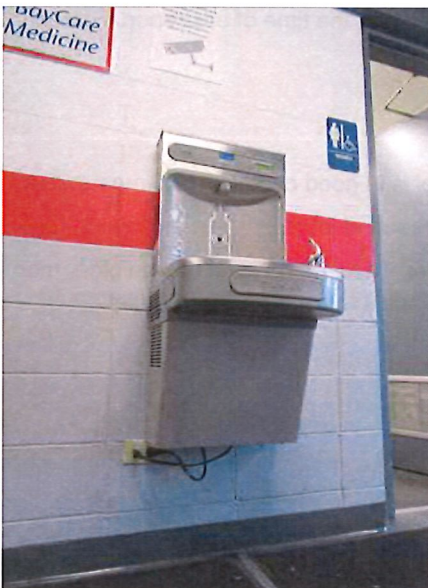
ADA ACCESSIBLE EWC
WBOTTLE FILLER

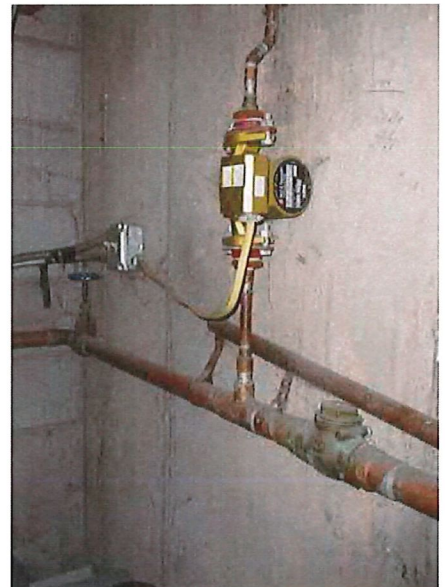
- Age of water heater and storage tank are exceeding normal service life and efficiency is in question.
- Storage tank has torn insulation blanket and condition of tank interior is in question
- Recirculation pump appears to be in good condition.

RECIRCULATION PUMP

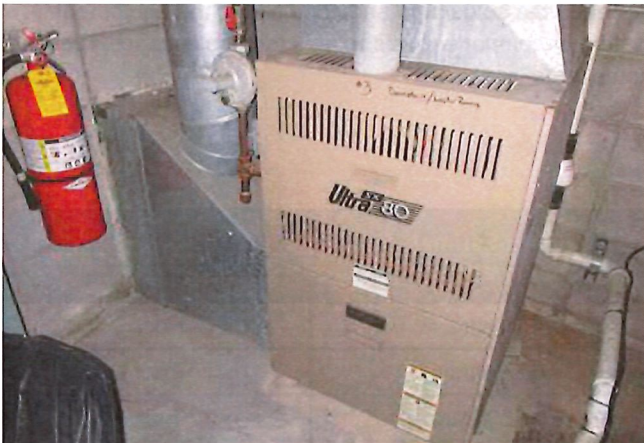
FURNACE #3

- Furnace #1 and #3 are well past their estimated service life expectancy, according to American Society of Heating, Refrigerating and Air-conditioning Engineers (ASHRAE). Furnace #2 is nearing its estimated service life expectancy. Due to age, maintenance can be expected to increase further.

- Implement a contingency plan to replace furnaces that have exceeded their estimated service life expectancy. Recommend replacement to be with sealed combustion, high efficiency, condensing furnaces.
- Consider replacing flue venting for unit heater.
- Consider replacing wood gas piping supports on roof with UV resistant rubber or plastic supports with Unistrut for pipe attachment.

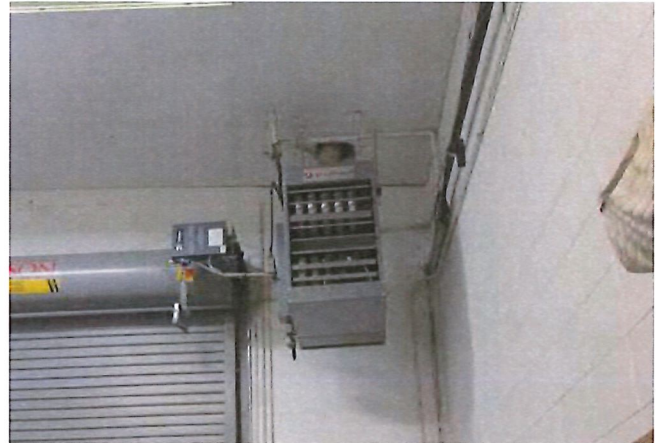
- Electric baseboard heaters are well past their estimated service life. Due to age, they could eventually fail to energize.
- When unit heater was replaced five years ago, existing venting was reused. Unit heater (low heat gas appliance) flue venting through roof is less than 10 feet horizontally from higher portion of building, so its vent termination should be installed a minimum of 2 feet higher than taller portion of building. When unit heater was replaced less than five years ago, venting should have been addressed to comply with Fuel and Gas Code.

UNIT HEATER

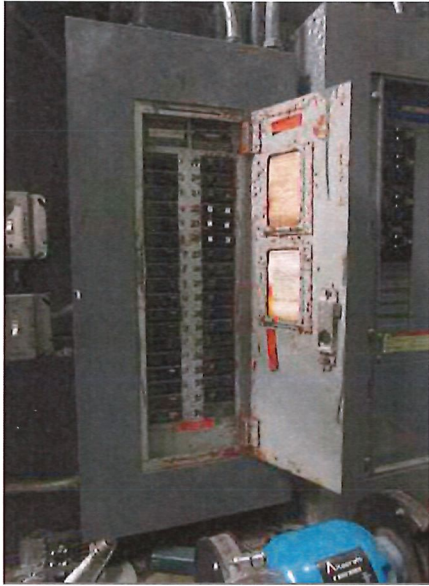
- The branch panels in the Ice Plant and Janitor’s Closet need to have clear floor space in front of them per National Electrical Code (NEC) 110.26 Working Space. There is a work bench in front of the branch panels in the Ice Plant that impedes into the working space.

BRANCH PANEL

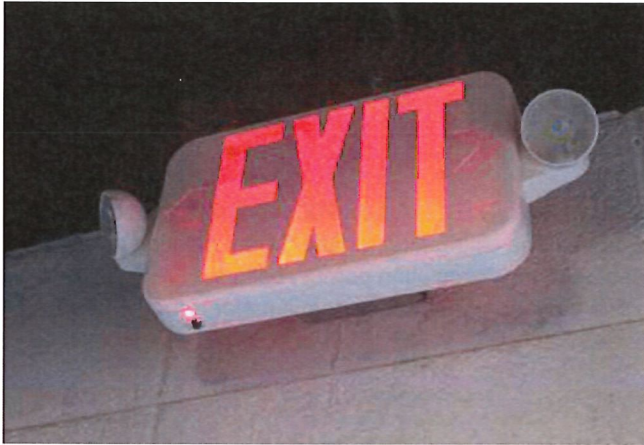
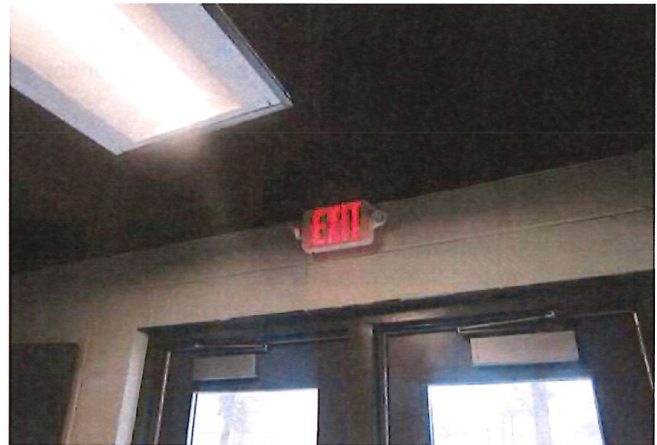
- Lack of automated controls such as occupancy sensors can result in energy over-usage. An occupancy sensor has the ability to automatically turn off luminaires in areas when unoccupied. The International Energy Conservation Code (IECC), Chapter 4, section C405 requires the use of automated controls.
- Although the exit signs have battery back-up lamp heads for emergency egress lighting, that may not be sufficient to cover the "path of egress" in all areas of the building. The "path of egress" is an unobstructed path to exit buildings or structures and shall be illuminated as required by the International Building Code (IBC), Chapter 10, Section 1008. This code requires illumination level of 1.0 footcandle at the walking surface and 10 footcandles in exit stairways.

EMERGENCY LIGHTING

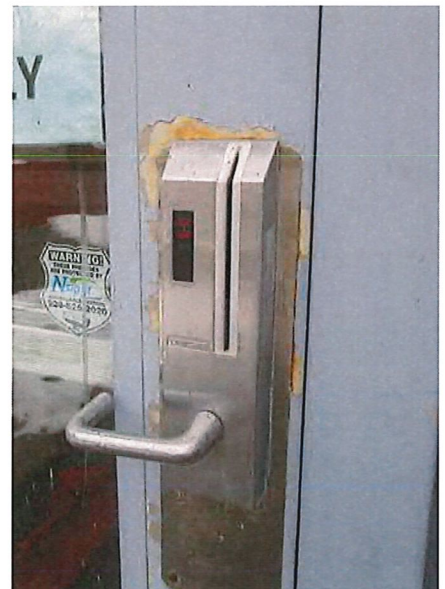
CARD ACCESS

- Security systems should be replaced.
